Another ECDIS induced accident: After all these years, why can't we get it right?

T. Porathe, E. S. Petersen, M. Lützhöft

The ErgoShip conference, Esbjerg, Denmark, 2-3 November 2023

Report on the investigation of
the grounding of the general cargo vessel
Kaami
on Sgeir Graidach, the Little Minch, on
23 March 2020

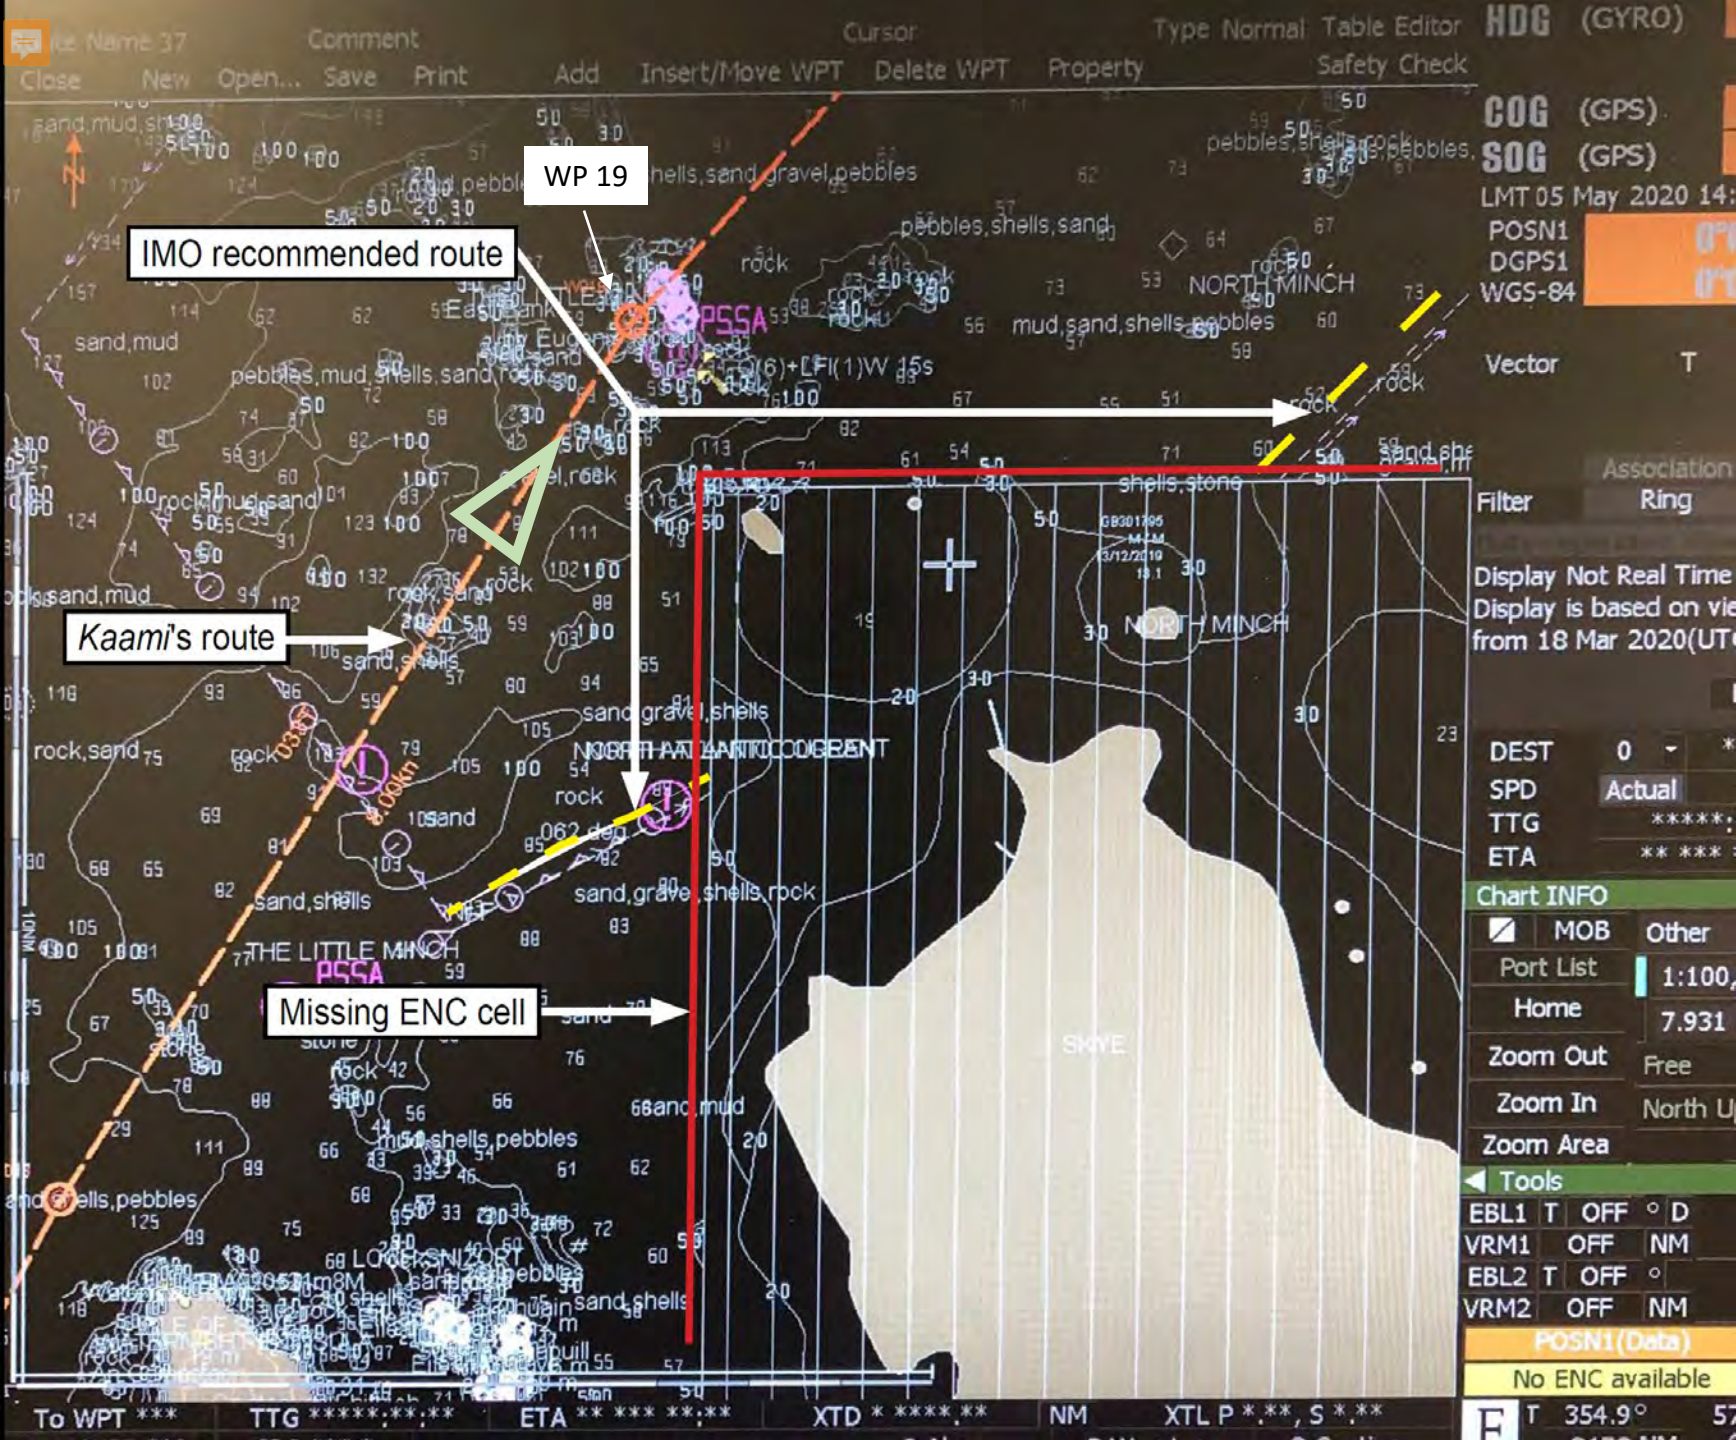
Figure 12: Photo of Kaami's ECDIS display showing route in comparison to the missing cell (indicated by vertical bars) which covered the IMO recommended route to the north of the Isle of Skye. Courtesy of MAIB.

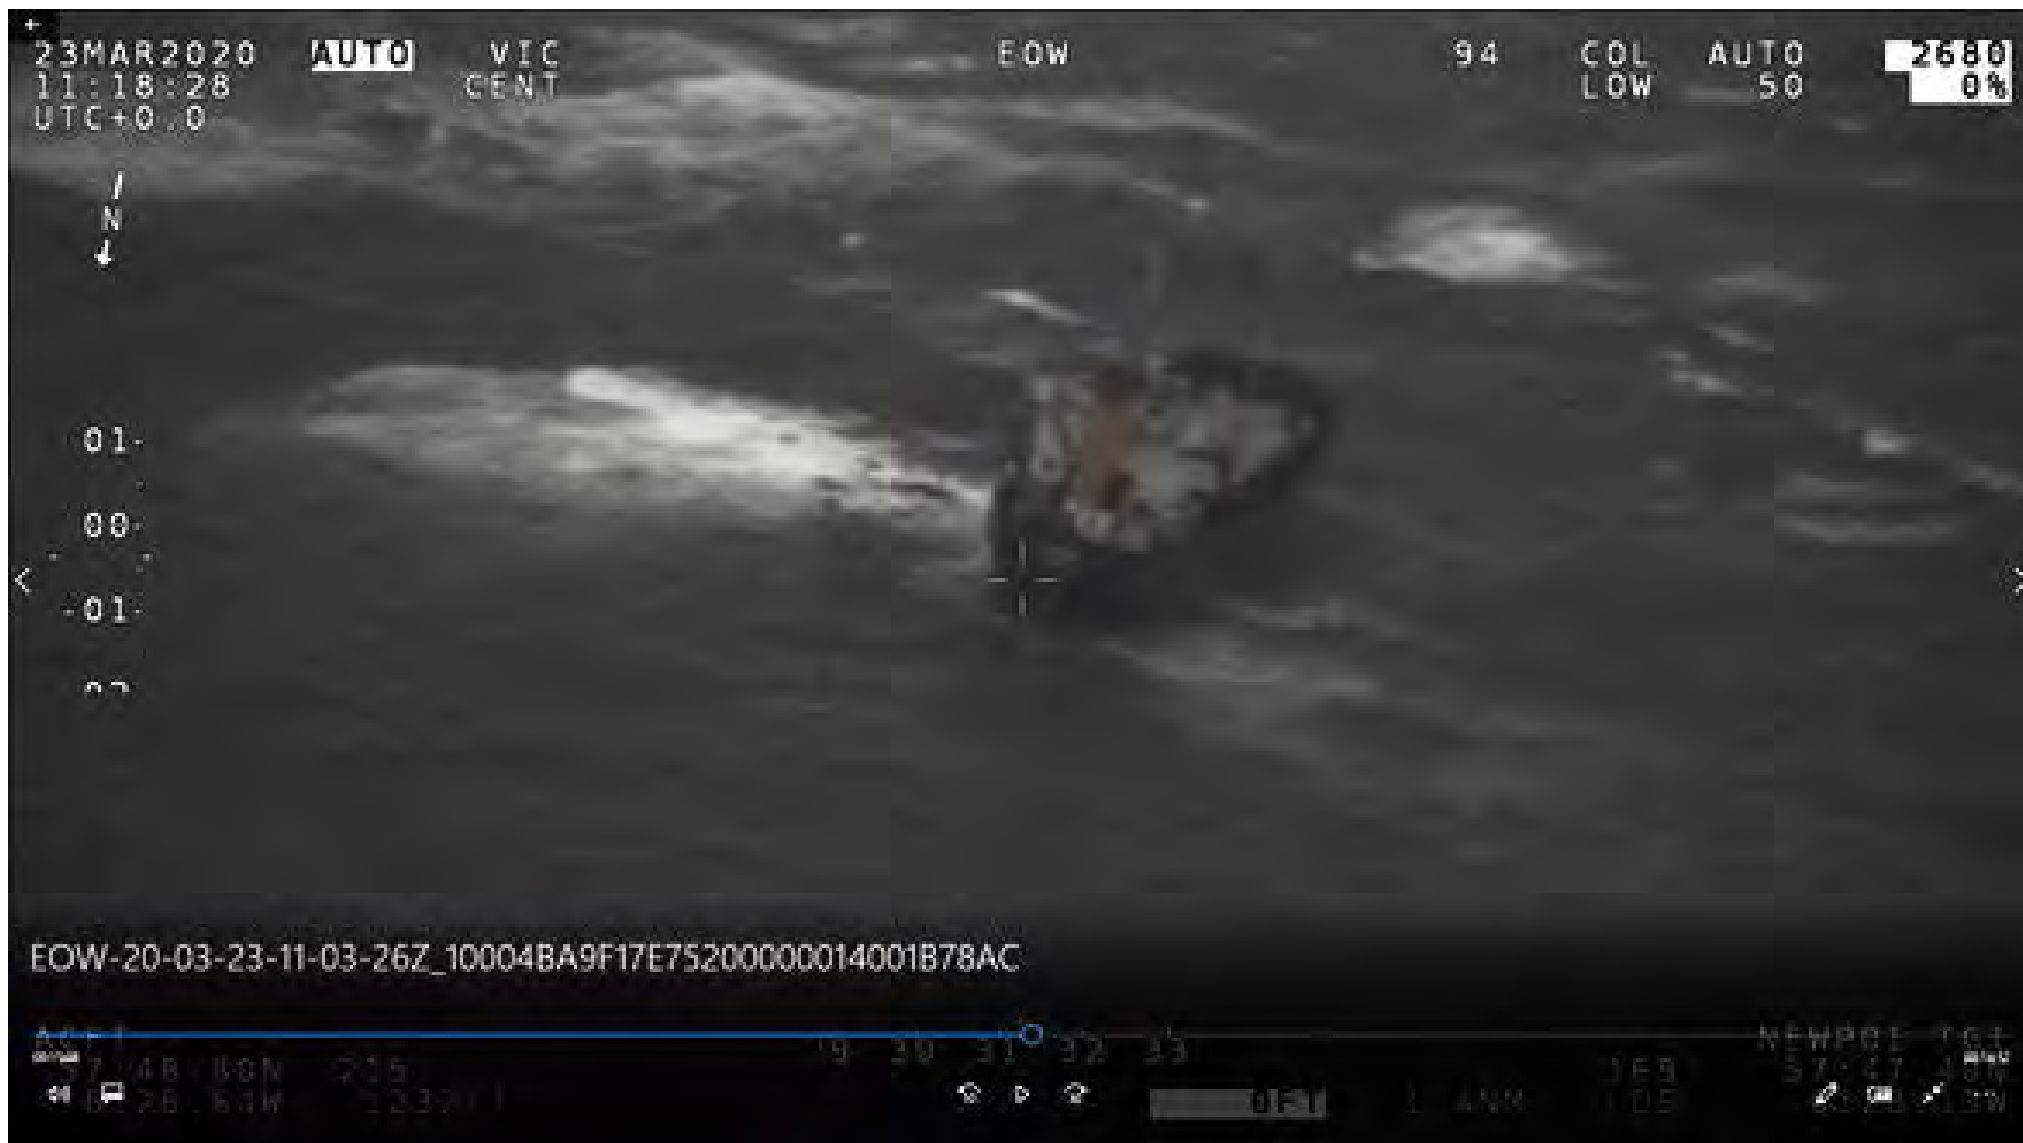
Figure 4: Aerial view from coastguard helicopter's video showing the general cargo vessel *Kaami* aground on *Sgeir Graidach*. Courtesy of MAIB.

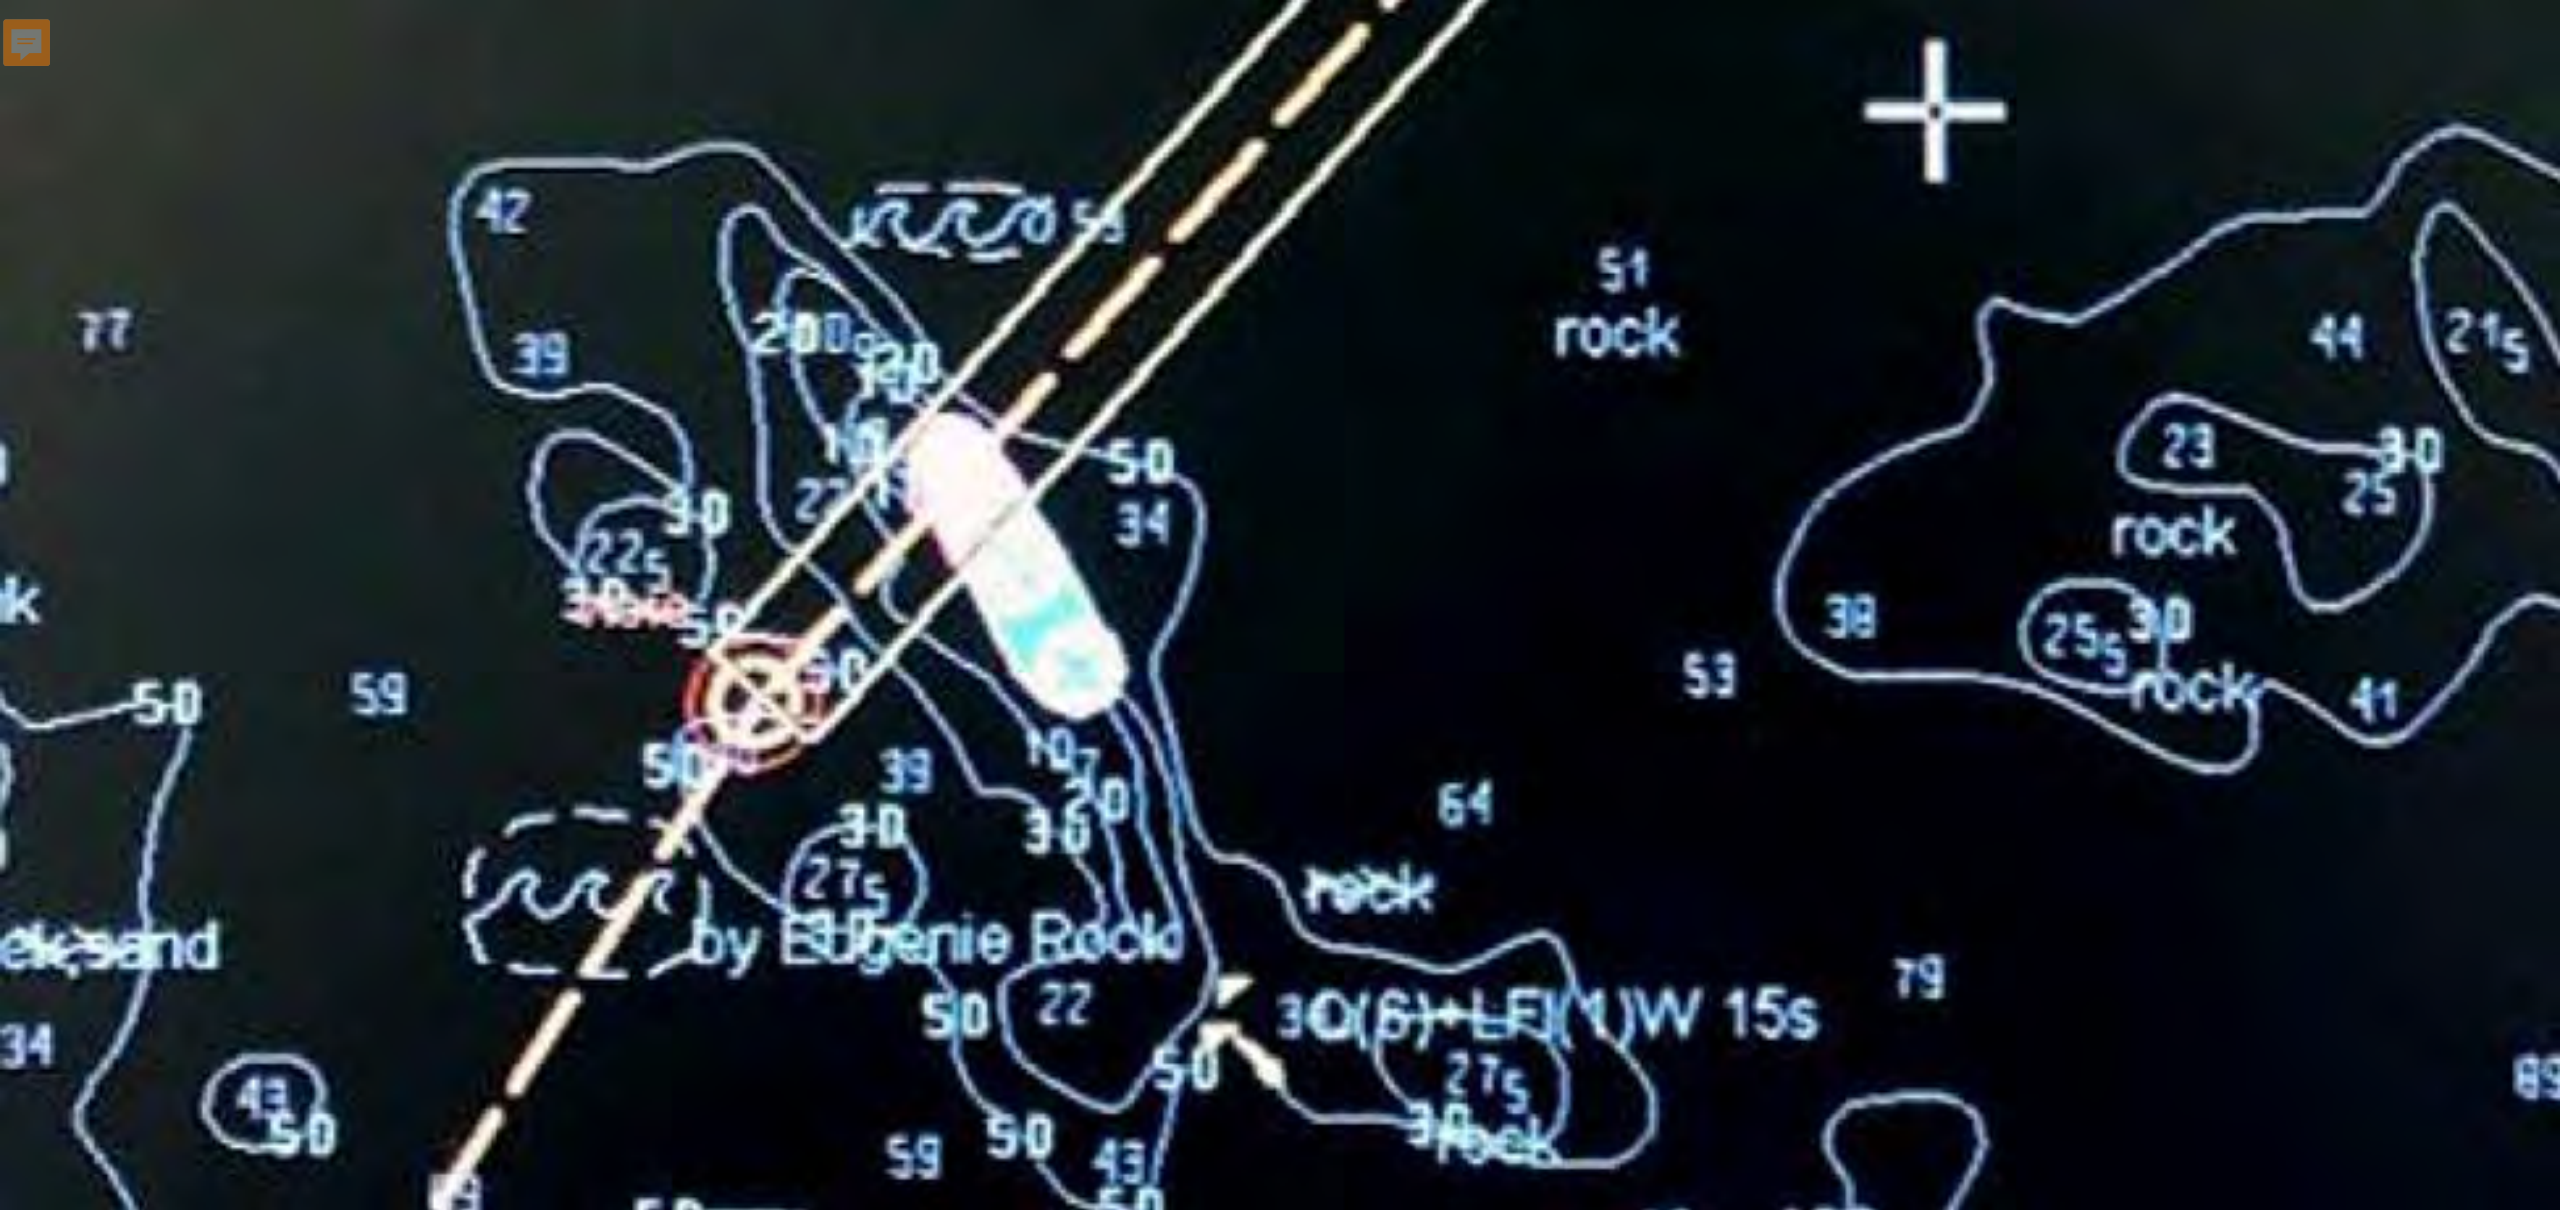
Kaami's route passing over shoal waters after WP 19. Photo from the ship's ECDIS. Courtesy MAIB.

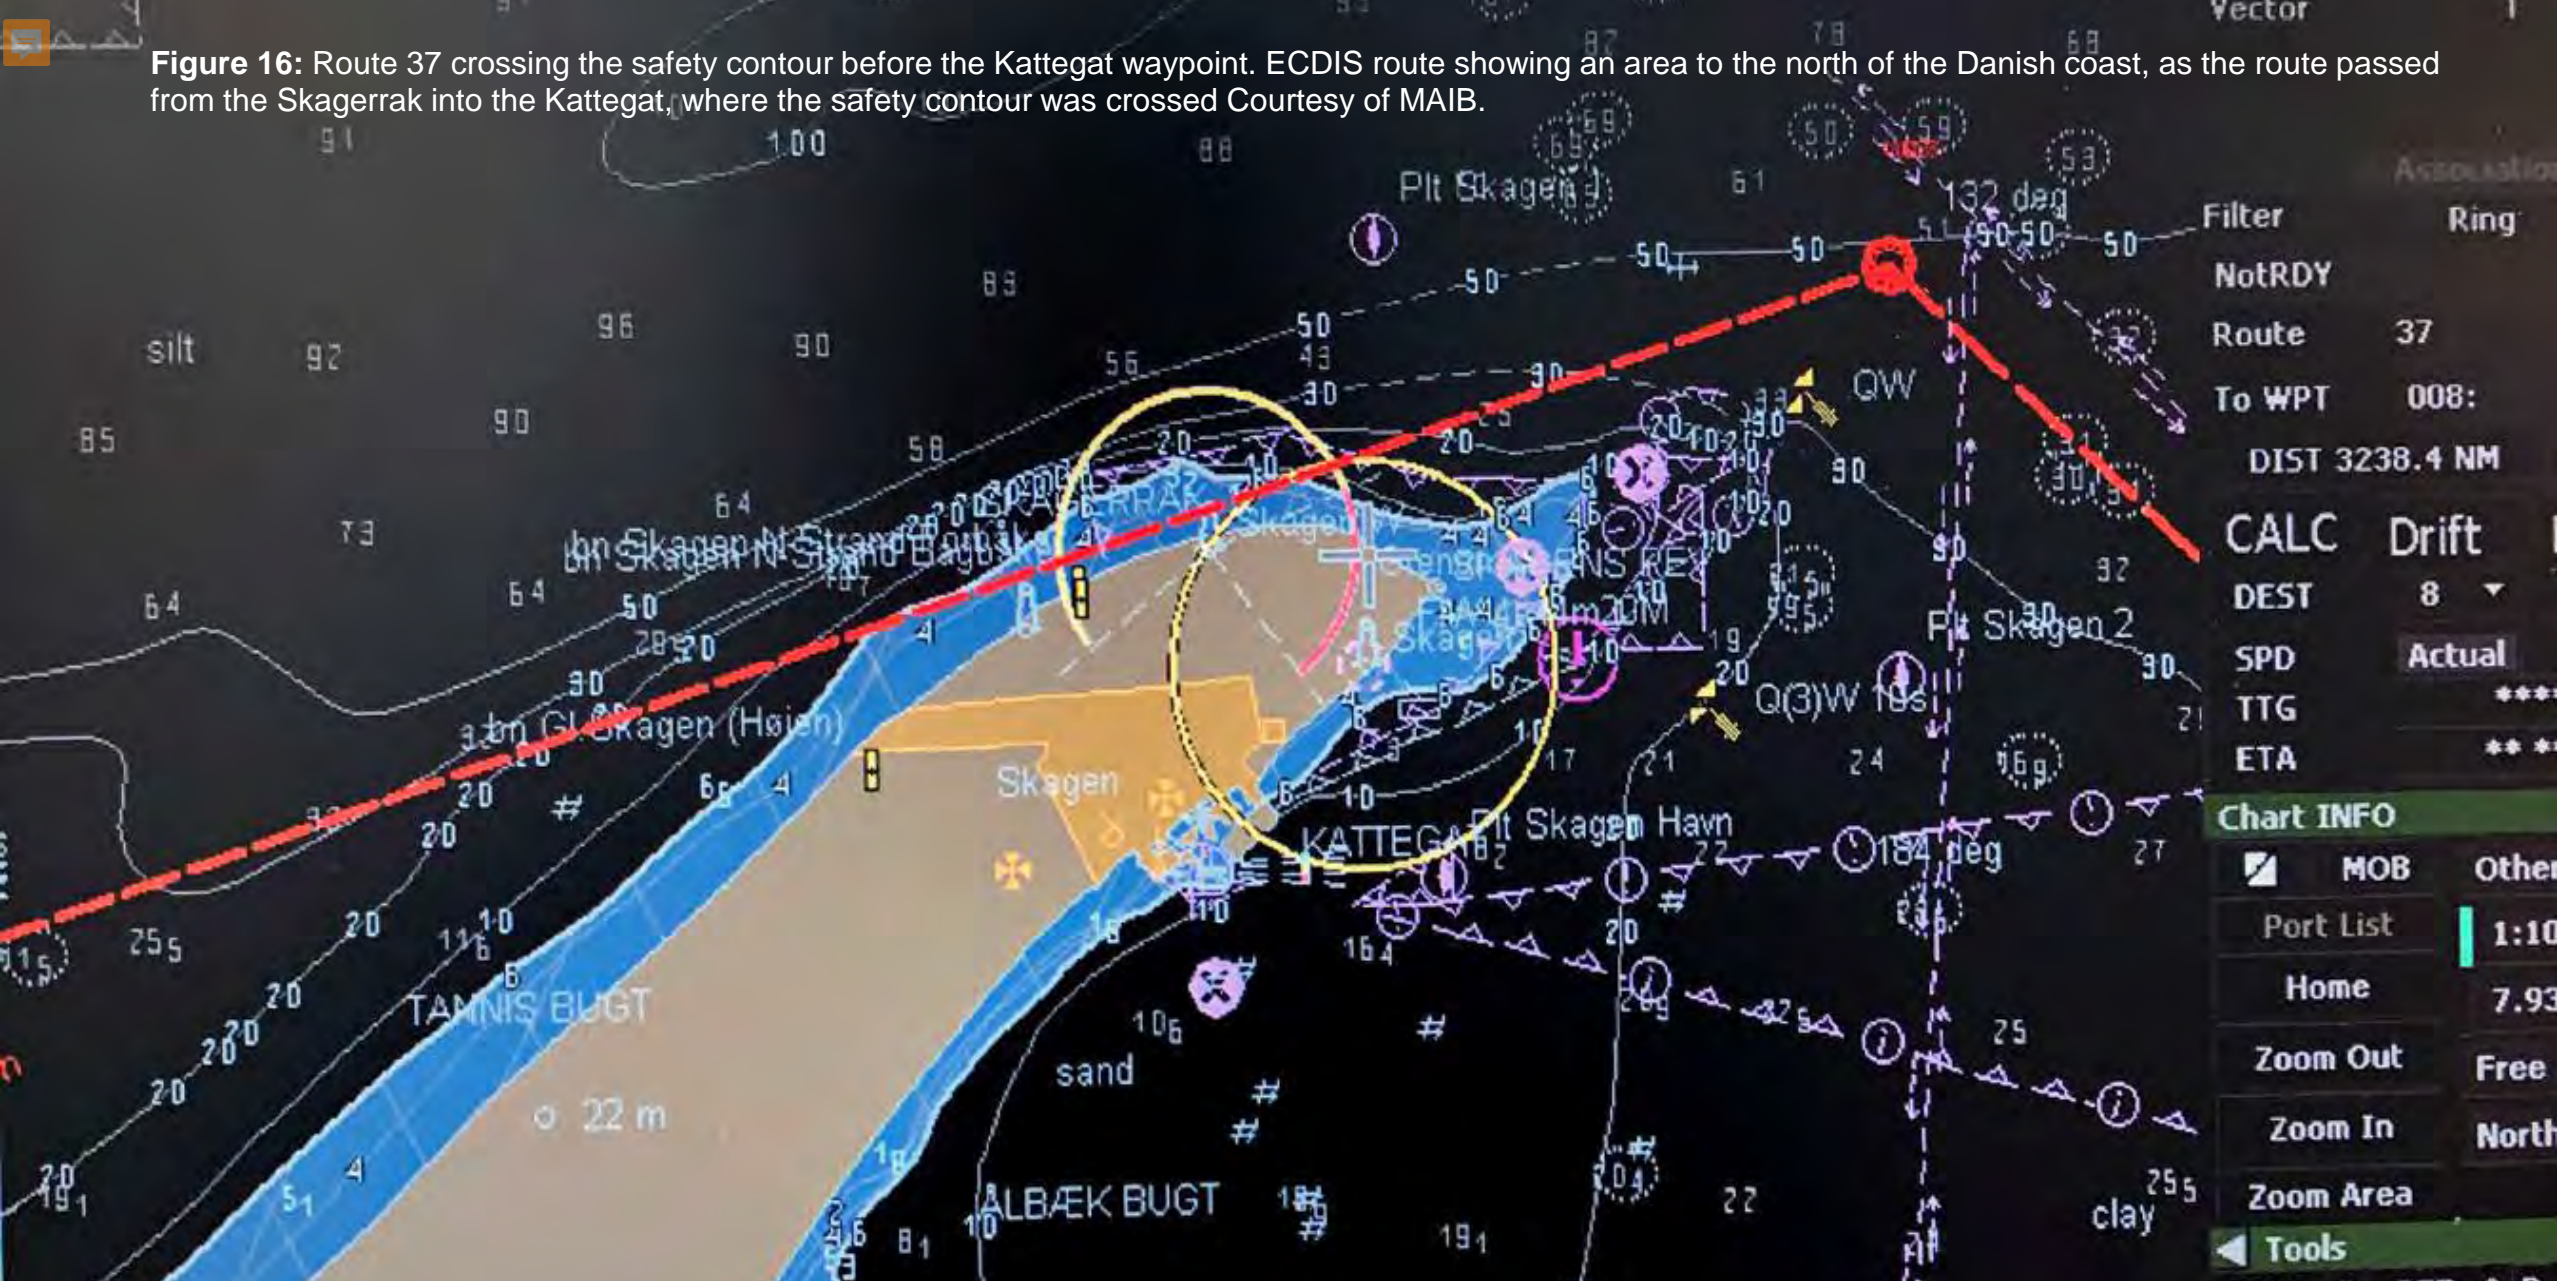
Figure 16: Route 37 crossing the safety contour before the Kattegat waypoint. ECDIS route showing an area to the north of the Danish coast, as the route passed from the Skagerrak into the Kattegat, where the safety contour was crossed Courtesy of MAIB.

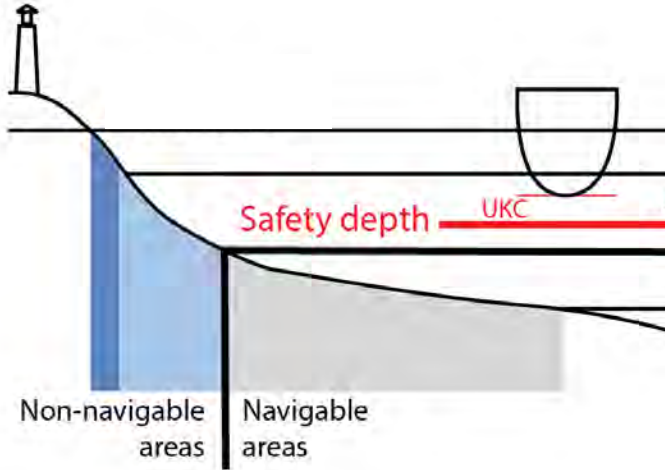
Kaami's draught 5.4 m (aft) + Under-Keel Clearance (UKC)

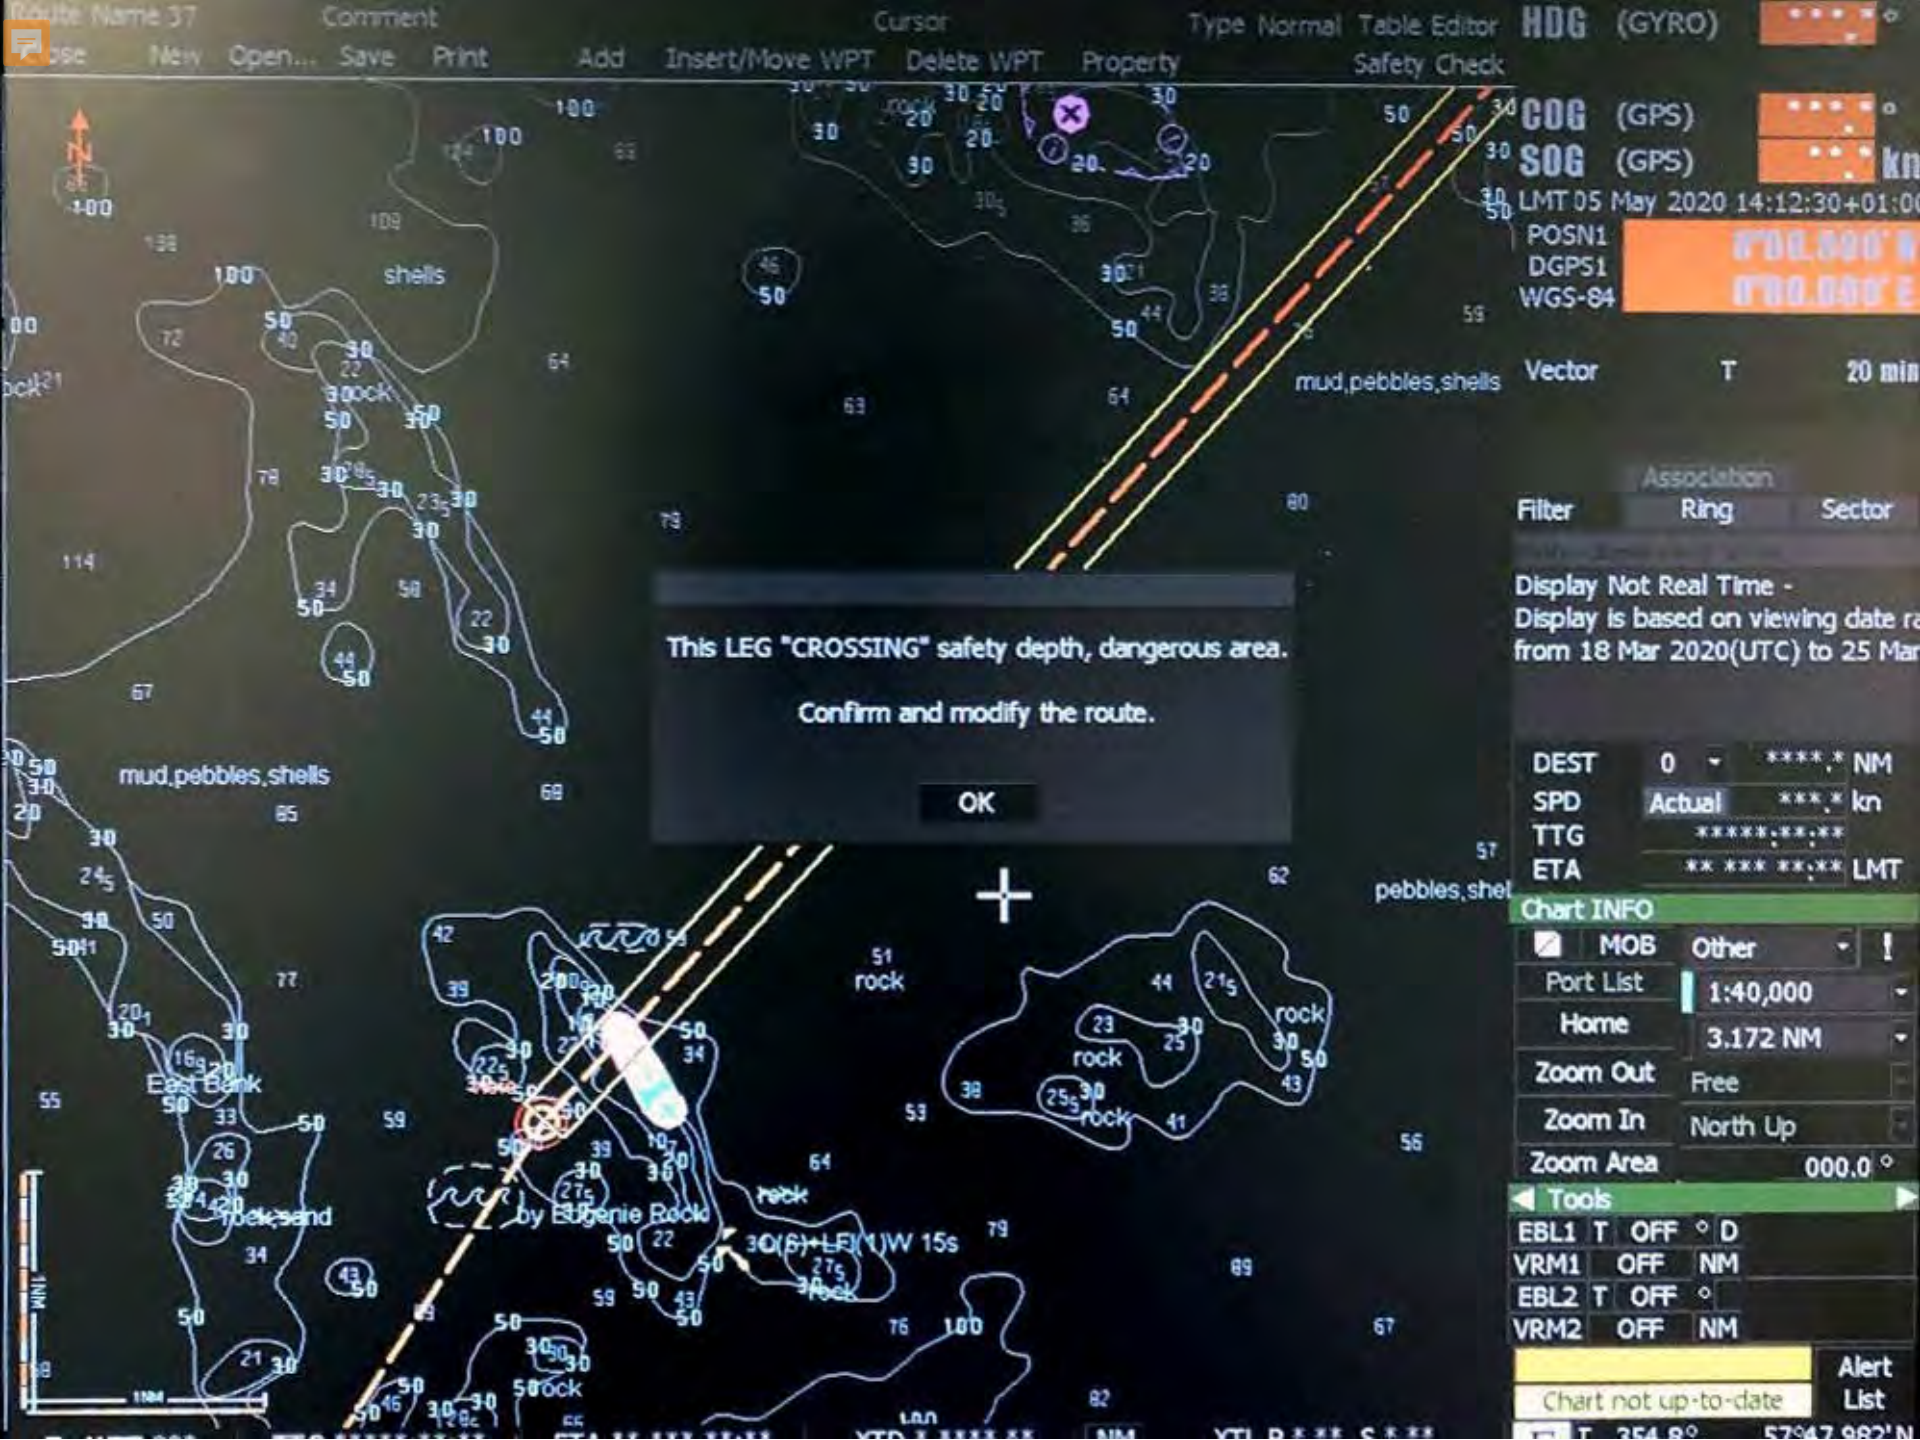
Figure 14: Automatically generated alarm for crossing a safety contour. Courtesy of MAIB

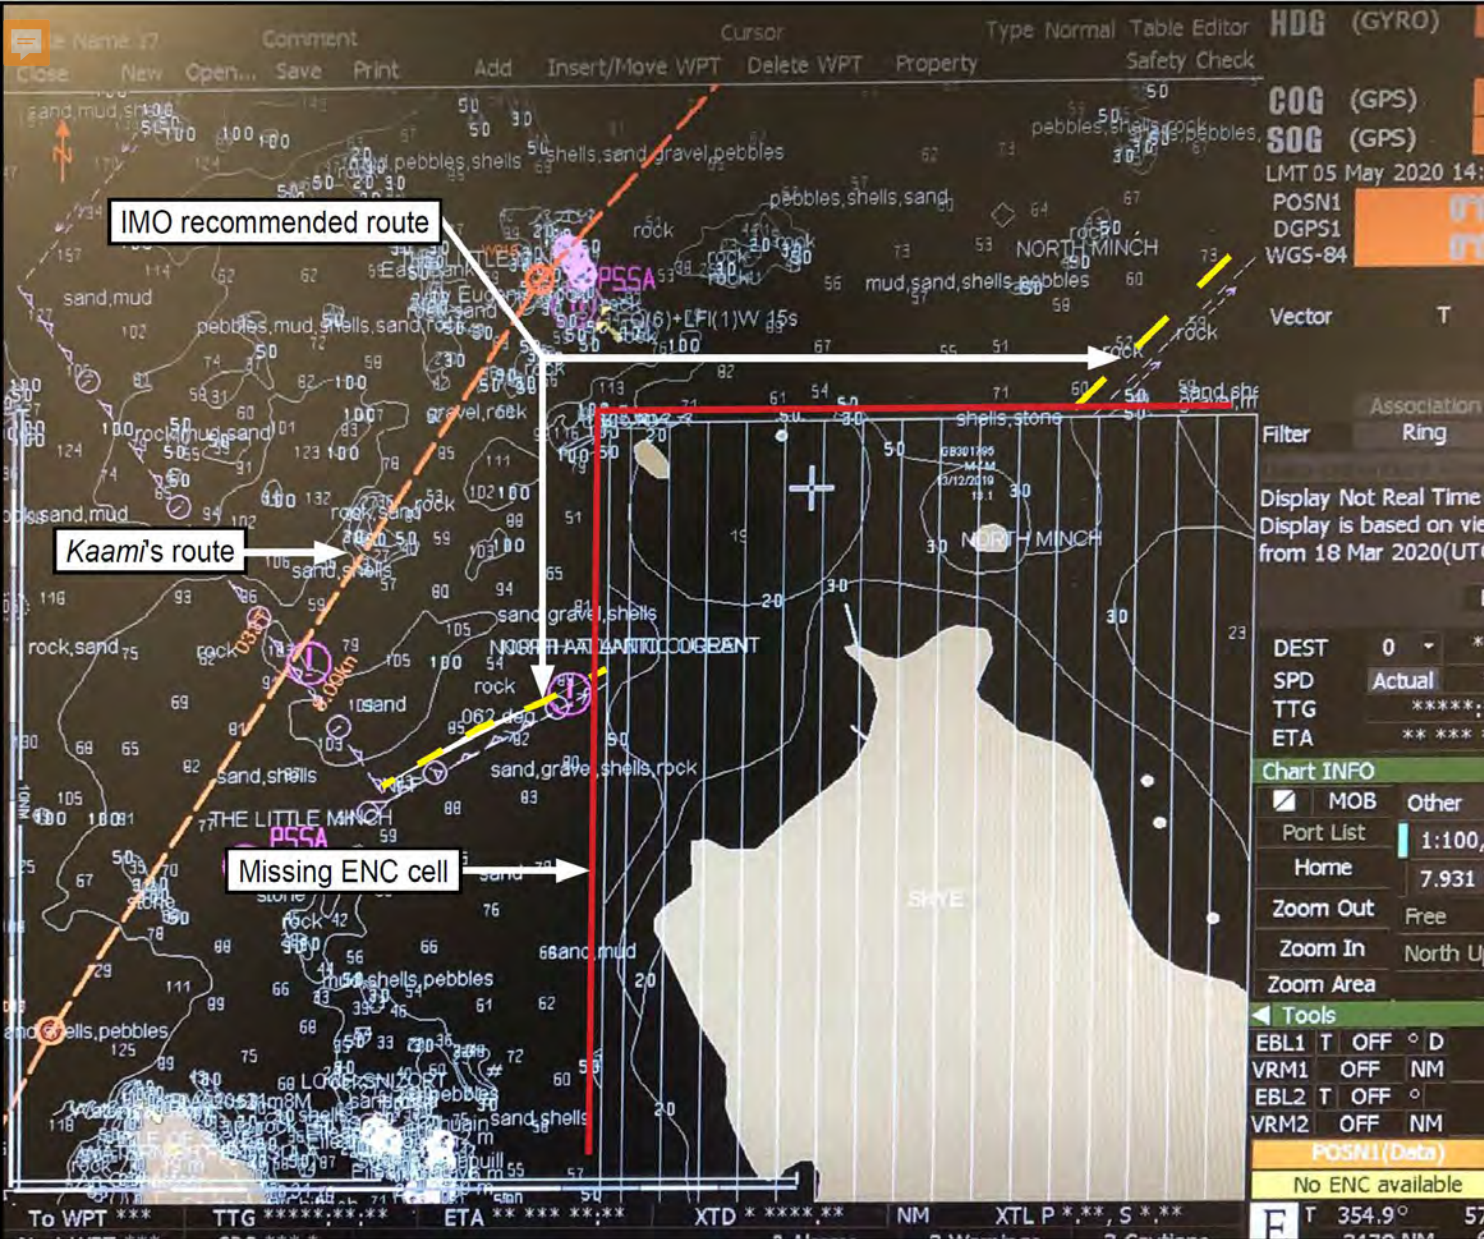
Figure 12: Photo of *Kaami's* ECDIS display showing route in comparison to the missing cell (indicated by vertical bars) which covered the IMO recommended route to the north of the Isle of Skye. Courtesy of MAIB.

Missing ENC cell

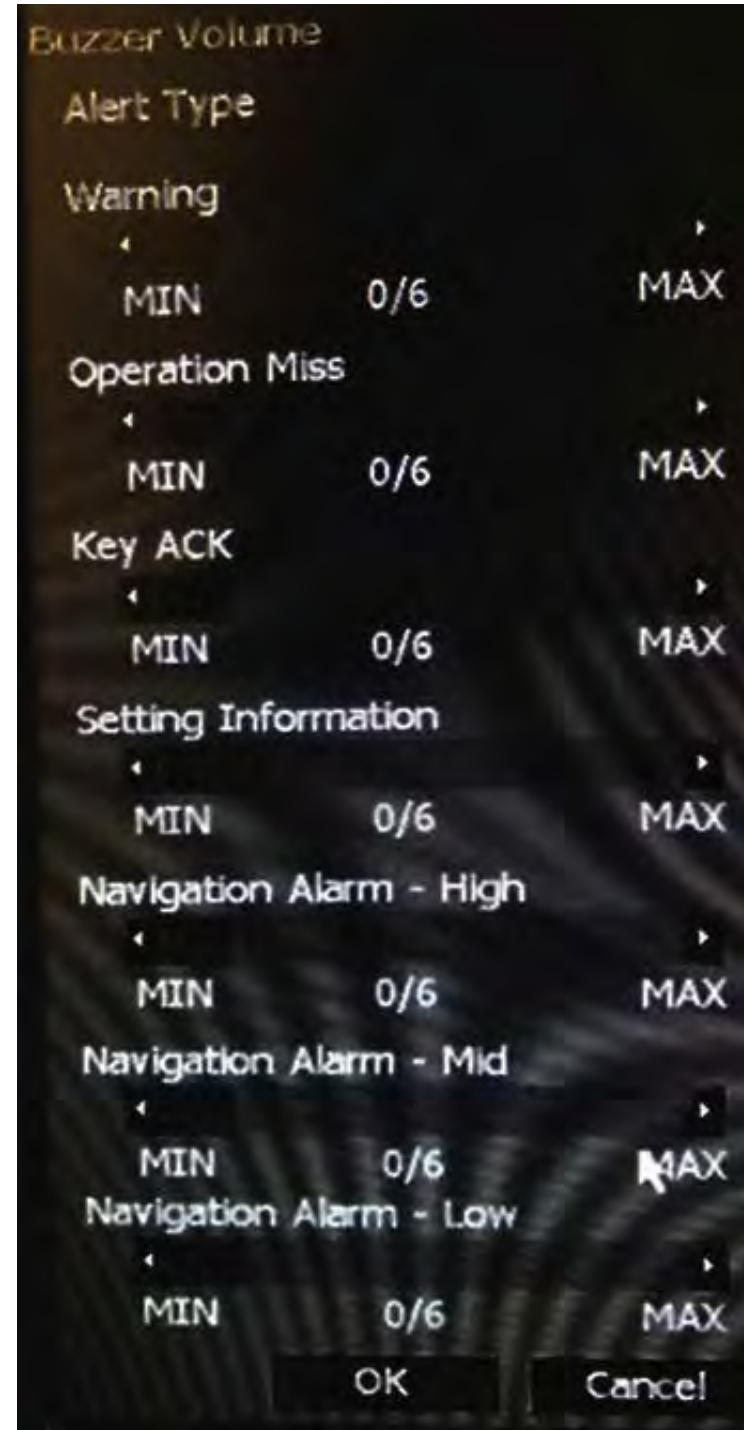
Figure 10: Alert buzzer settings all set to zero
