The Drogheda boat and clinker boats of the Renaissance on Europe's western seaboard

Holger Schweitzer

**Ph.D. thesis
submitted December 2013 to
the University of Southern Denmark**

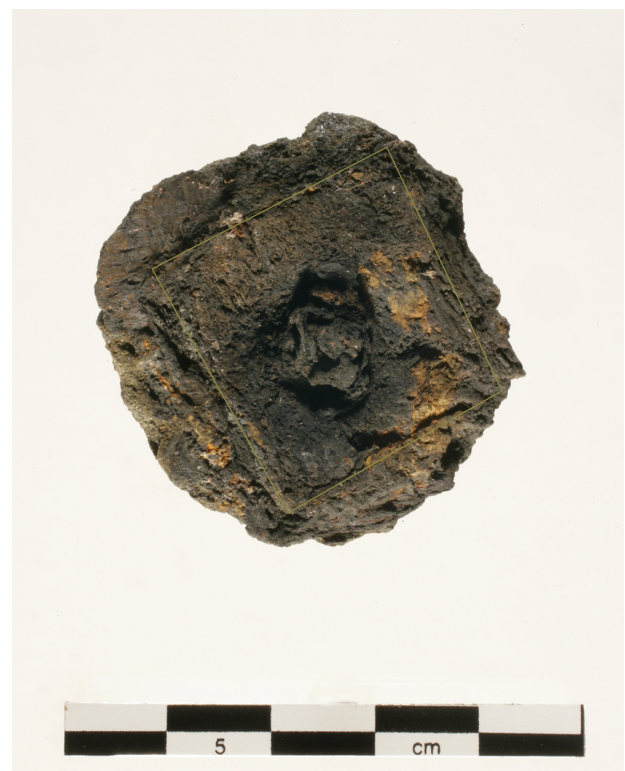
Figure 3-20: Concreted rove with outline highlighted in red (after Brogan 2009)

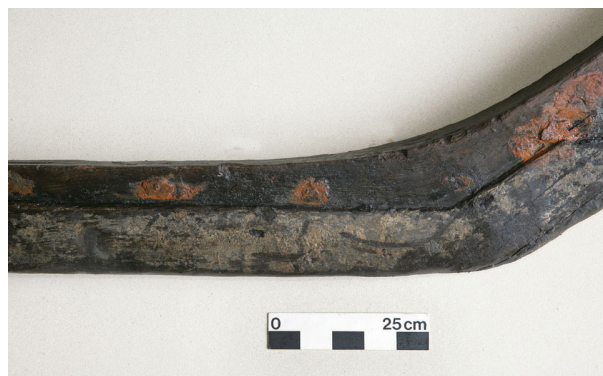
Figure 3-24: Detail of stempost with protective coating (Brogan 2009)

A whitish soft creamy material covered the outboard surfaces of most planks, keel, stem and stern hooks (Fig. 3-24). Although its extent varied significantly with some planks even showing almost no coating remnants, this can most likely be attributed to loss as result of erosion or handling during excavation and recovery. Considering the overall consistent and extensive presence of the coating, it appears likely that it originally covered the entire outboard hull. Analysis of the material by the State Laboratory in 2007 showed that its main component was a pine resin pitch. Unfortunately it was not possible to determine the exact pine species used to source the resin (The State Laboratory, 2007). Further chemical analysis identified terrestrial sulphur in several luting samples suggesting that it was deliberately used rather than a coincidental occurrence (Davis et al., 2009).

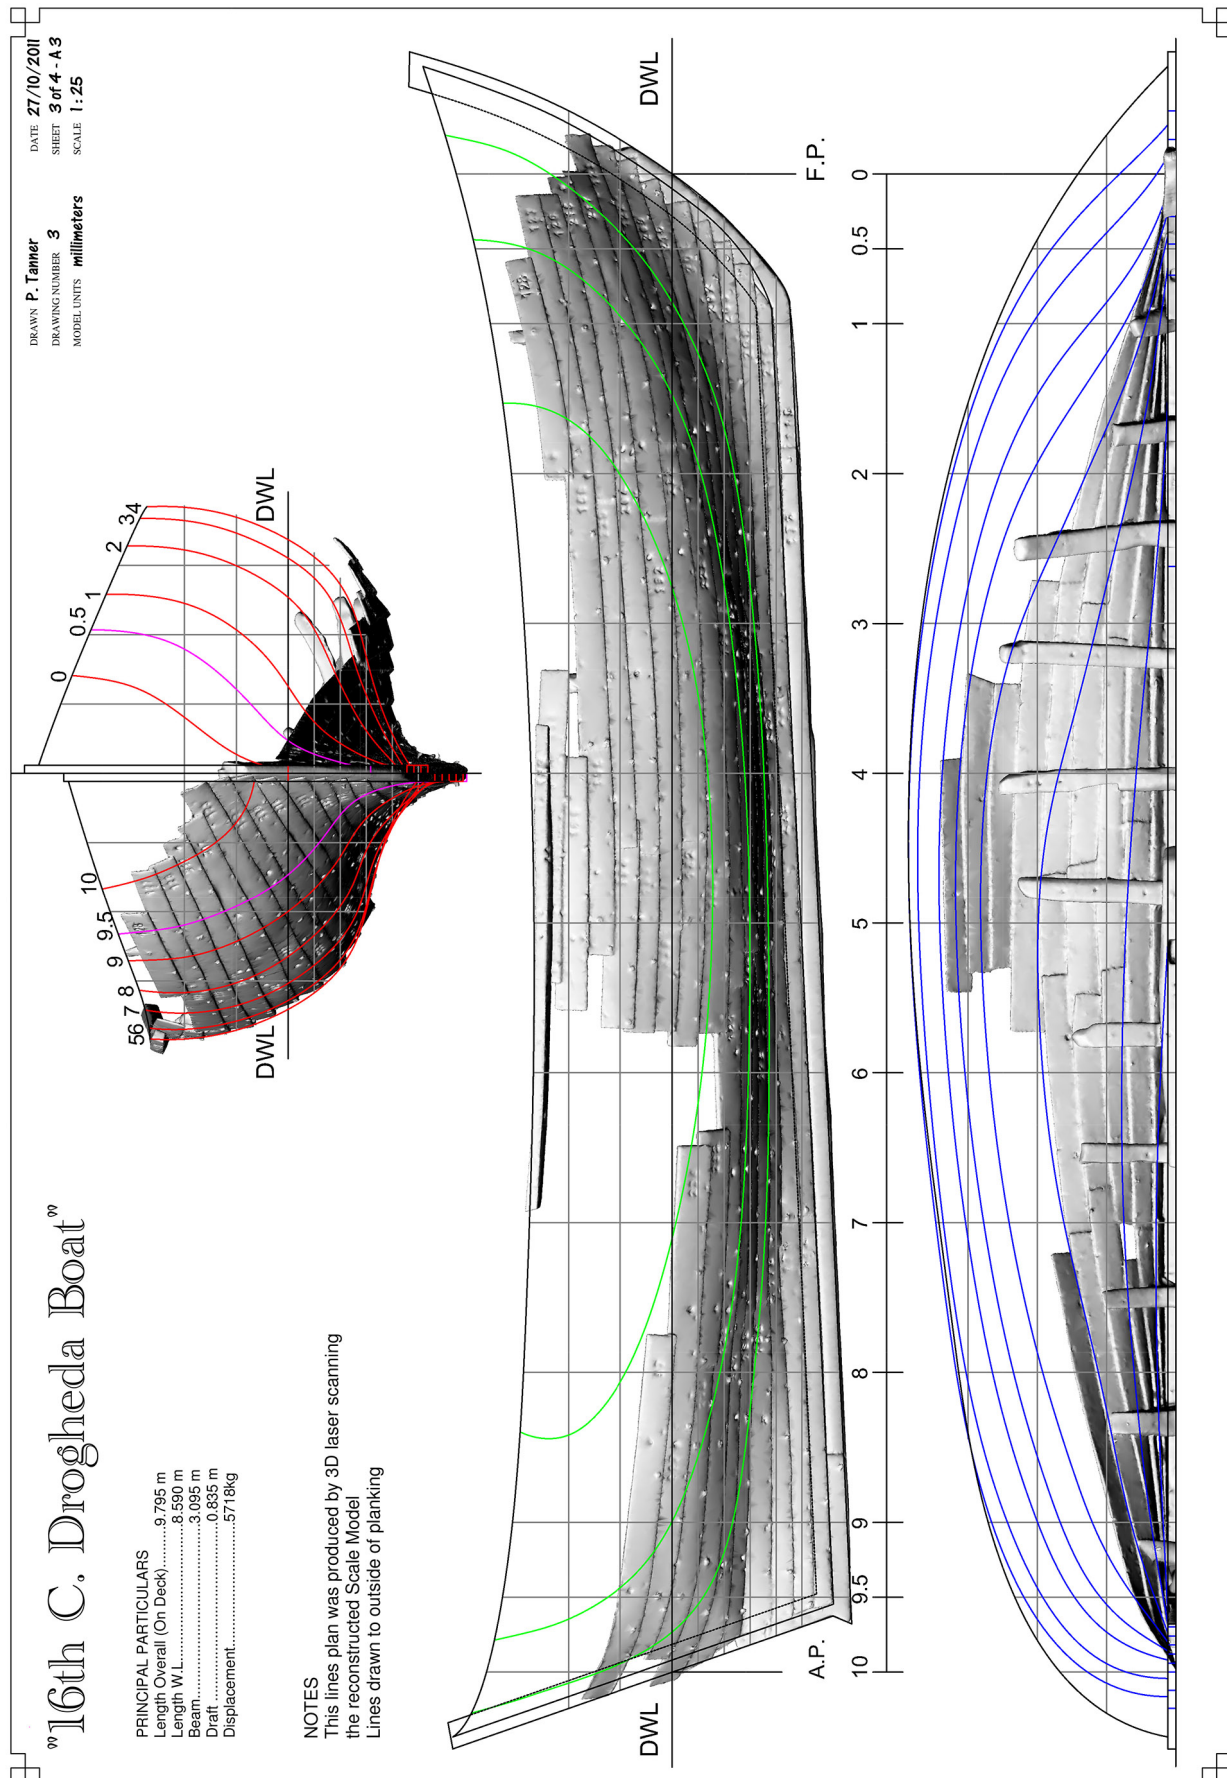
Figure 3-42: Lines plan of the Drogheda boat based on the processed laser scanned 1:10 scale model overlaid with laser scan image of the scale model (Tanner 2011)

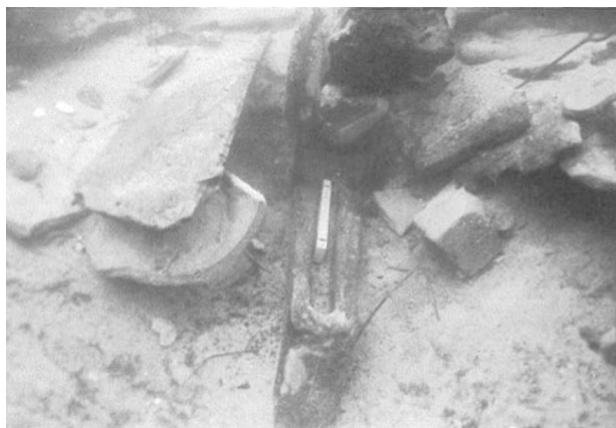
Figure 4-51: Stern end of keel with mortise for sternpost of Lundeborg 2 wreck (Skaarup, 1979 p. 70)
