Field Survey in Vezirköprü and Havza Districts, October 2013

Ass.Prof. Dr. Tønnes Bekker-Nielsen, director

REPORT

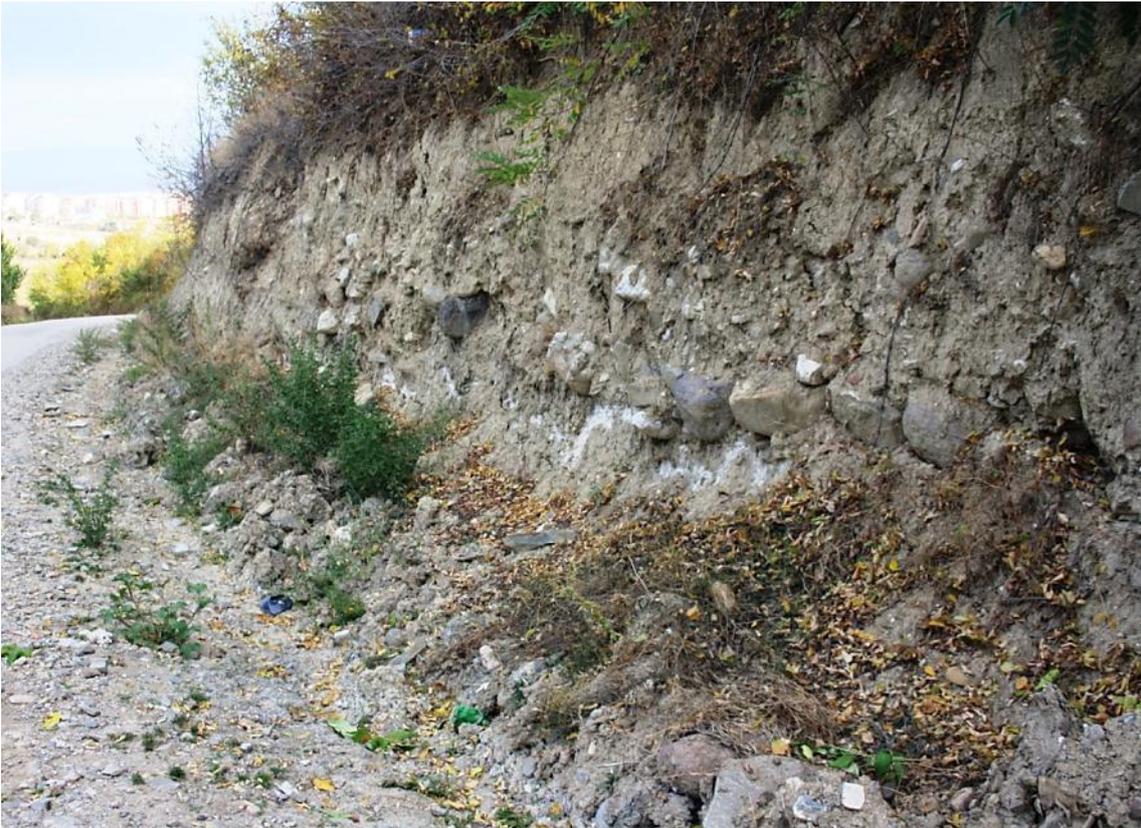
On the ascent from the Esenli çay to Doyran village, the ancient road ran just left (east) of the modern road. Over a distance of c. 60 metres, a longitudinal section through the ancient roadbed was exposed in 2010 (fig. 1). The face of the section is being eroded away at a rate of c. 15 cm/year, and new ceramic fragments have been exposed that were invisible in 2010. Pottery was collected for examination and dating and a rim fragment of a Pontic Sigillata form 9 of the mid to second half of the 2nd c. AD was identified (Zhuravlev 2011, pl. 3:4-5). Among the fragments collected in the preliminary season in 2010 reported on in 2012 was a possible Pontic Sigillata form 14-16 rim which dates in the 2nd to 3rd c. AD supporting a date in the late 2nd to 3rd century for the road (Zhuravlev 2011, 151, pl 1:17-19)

1. Exposed section of ancient road in Doyran

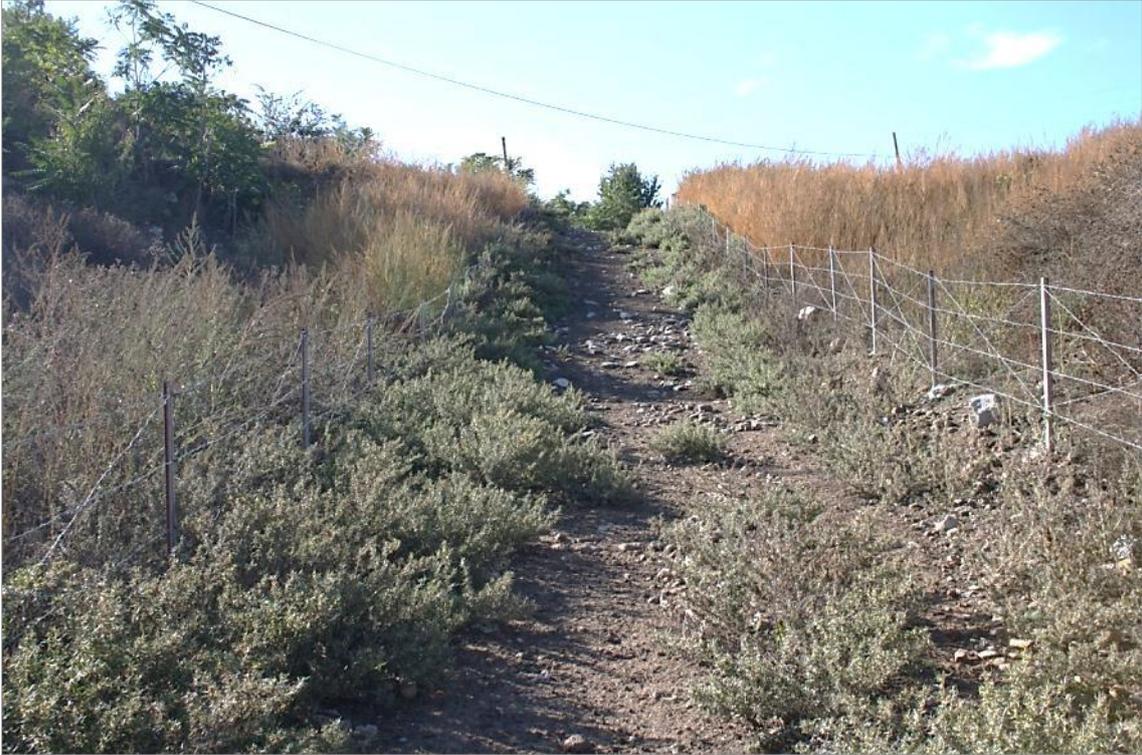
South of çeşme no. 3, the road turned west. Its ascent uphill is still visible (fig. 2).

2. Road leading upwards from Doyran village in direction of Havza

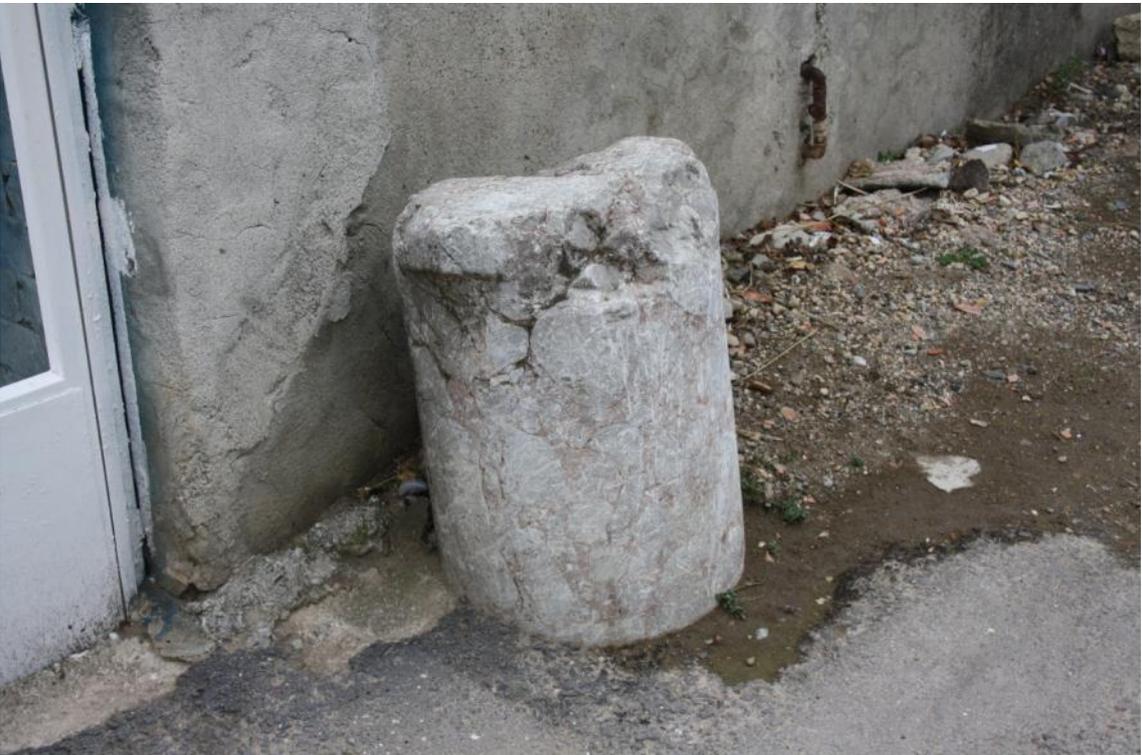
In Pazarcı village east of the modern highway, remains of two ancient columns were observed at UTM 710540/4549698 and 710630/4549762 (fig. 3).

3. Column stump in Pazarcı village

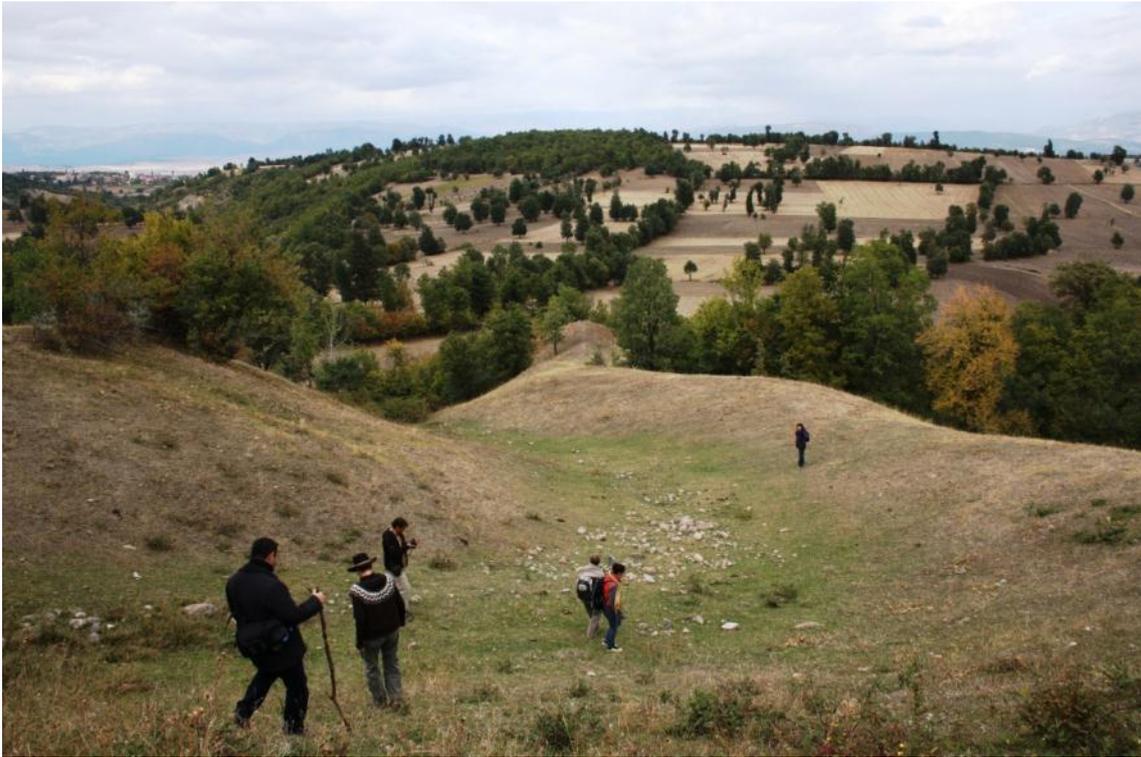
The western route shows no evidence of Roman surveying or engineering, and no finds are reported along its course. The eastern route climbs along a hollow way (fig. 4) gradually tapering inwards, the upper and narrowest end of which at UTM708295/4549358 is now so overgrown as to be impenetrable. The layout is strongly reminiscent of the ascent from the north towards Ortaklar (see below). From the upper end of the hollow way, it would be possible for the road to have followed a switchback course through UTM709357/4547038 entering Tepeören village at UTM708315/4549100 and merging with the village street around UTM708280/4548790.

4. Northern approach to Tepeören

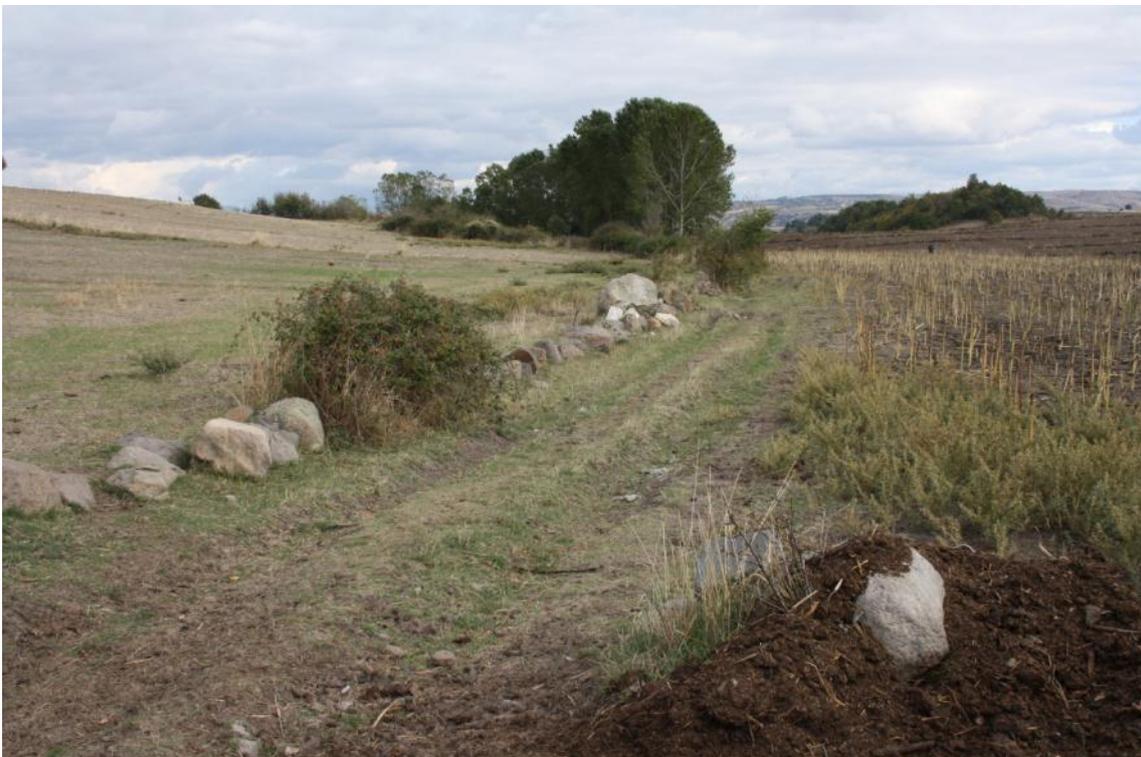
On a wide plateau adjoining the İstavroz çay ESE of Tepeören (fig. 5), copious amounts of pottery were observed on the surface over a large area. A selection was collected for further examination. A depression at UTM709590/4547585 was identified as a robbed tomb by a local informant, and the lighter colour of the soil in this area may imply the presence of one or more masonry structures (not necessarily tombs) under the surface. At UTM709771/4547481, erosion had exposed a grave and bones were visible in the vertical face of soil towards the river (fig. 6). In this south-eastern corner of the site an unusually large proportion of the surface finds were table wares, which supports the identification of the area as a necropolis although the location is unusual.

5. Field with extensive scatter of Roman pottery SE of Tepeören; in the distance, Kaledoroğu.

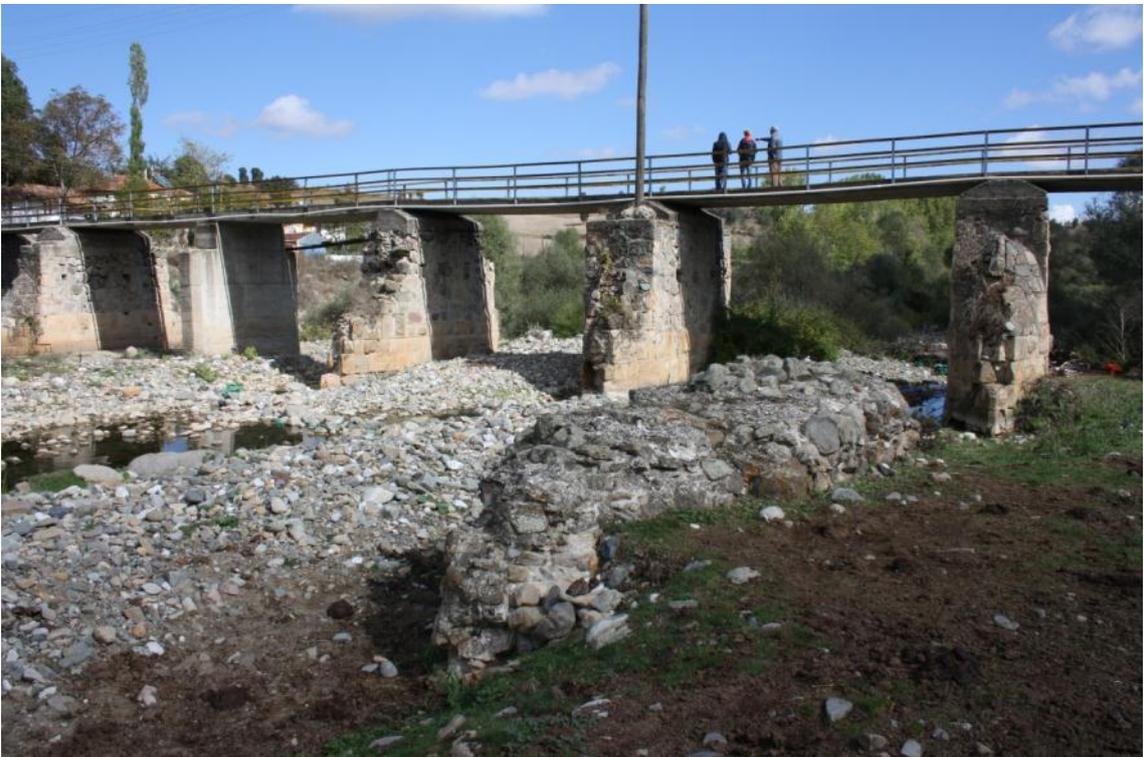
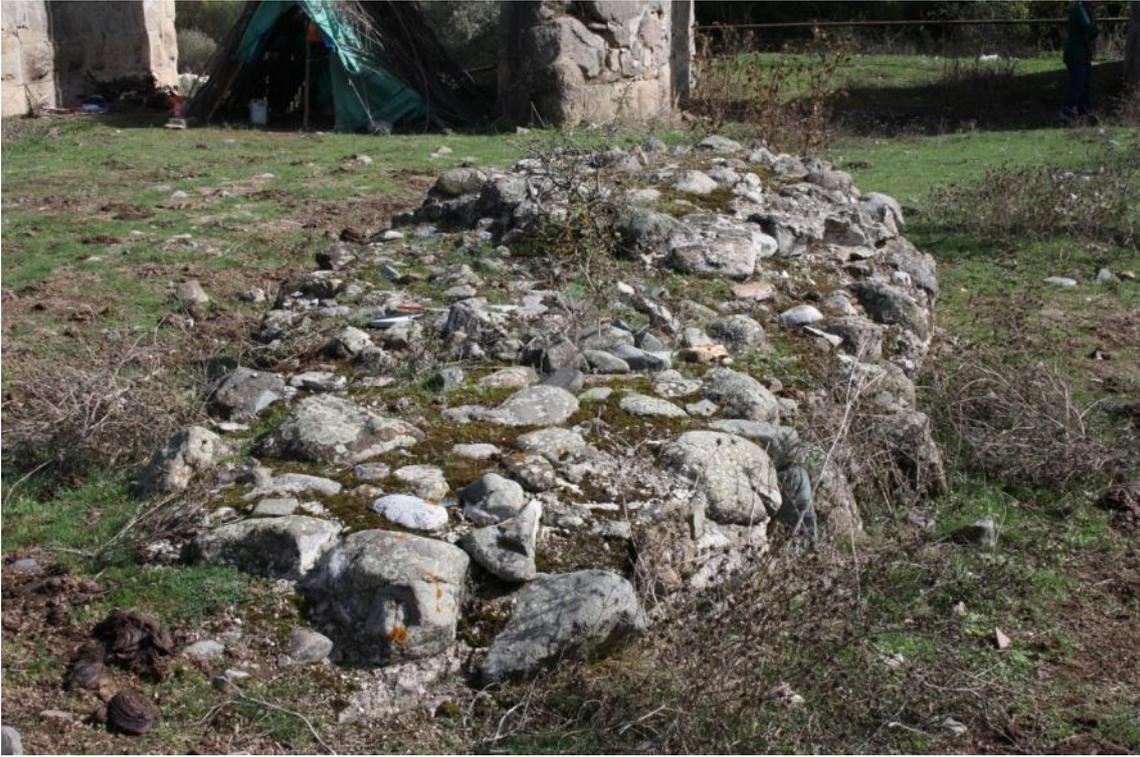
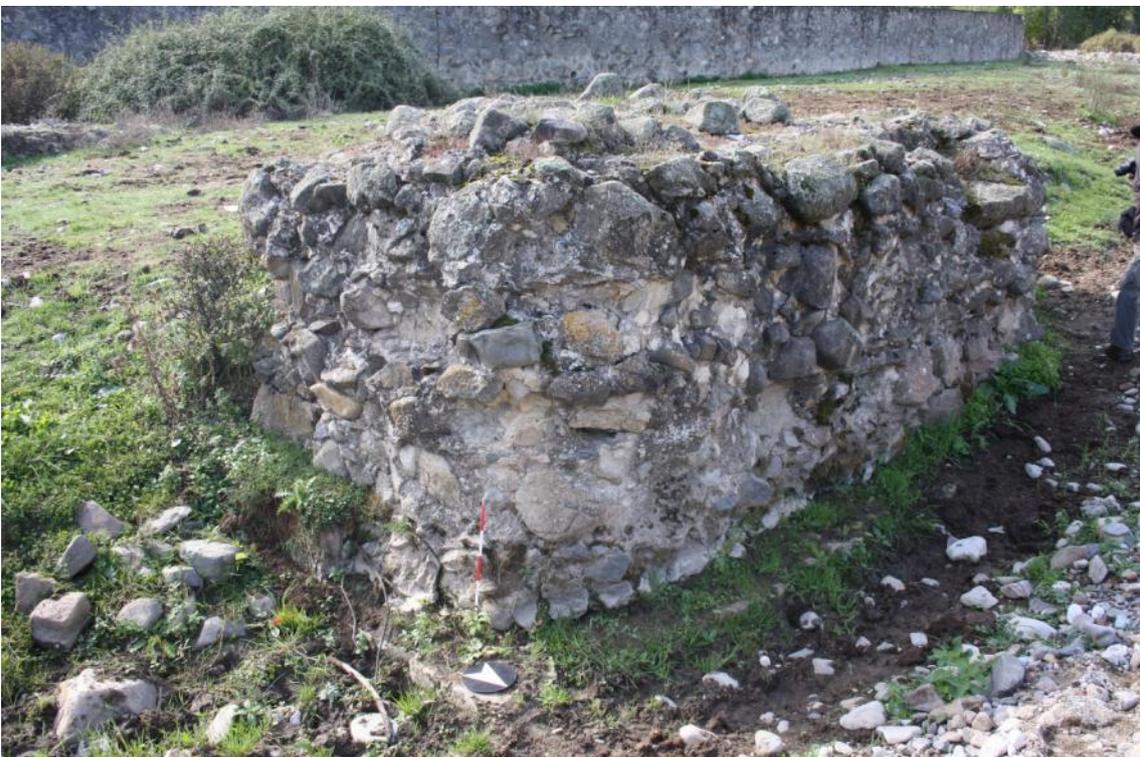
Just upstream of the old bridge at Köprübaşı, remains of a still older bridge are visible (figs 7-9): two piers in masonry with a core of stones and concrete, the only visible remains of what must have been at least five piers. The two piers have cutwaters on their upstream side, but not downstream: an indication that they are mediaeval or older. Both piers have lost most of their exterior masonry facing, but at one corner of the northern pier (UTM711504/4547205) the lowest visible course is preserved intact. The original width of the piers can be estimated at 3.0m (ten Roman feet). They are different in length: the southern 6.0m in its present state, the northern 7.1m.

A mill-race, probably constructed in the nineteenth or early twentieth century, runs along the southern bank and has obliterated all traces of the bridgehead, which was located c. 20m west of the present bridge. The presumed location of the first pier, counting from the edge of the mill-race, is covered in shrubs and bushes, but older photographs of the site show no masonry remains here. Piers no. 2 and 3 are preserved to a height of about 1m. There are no traces of pier no. 4 to be seen. Pier no. 5 may be buried under a mound of stone and gravel in the river bed.

Under the newer bridge immediately upstream of the ancient, the river bed is paved with large slabs. Their surface is rusticated, in a manner similar to that visible on some of the stones in the facing of the piers. Since this obviously makes the slabs unsuitable for paving purposes, we may conclude that the surfacing in the river-bed represents a re-use of facings slabs, probably from a collapsed pier.

The distance between the preserved cores of piers 2 and 3 is 9.3m; the original span may be estimated at 9.0m (30 Roman feet). The superstructure was probably made of wood. The span would be quite moderate for a Roman bridge.

7. Remains of ancient bridge piers at Köprübaşı; in background, later bridge.

8. Remains of pier 2.

9. Remains of pier 3.

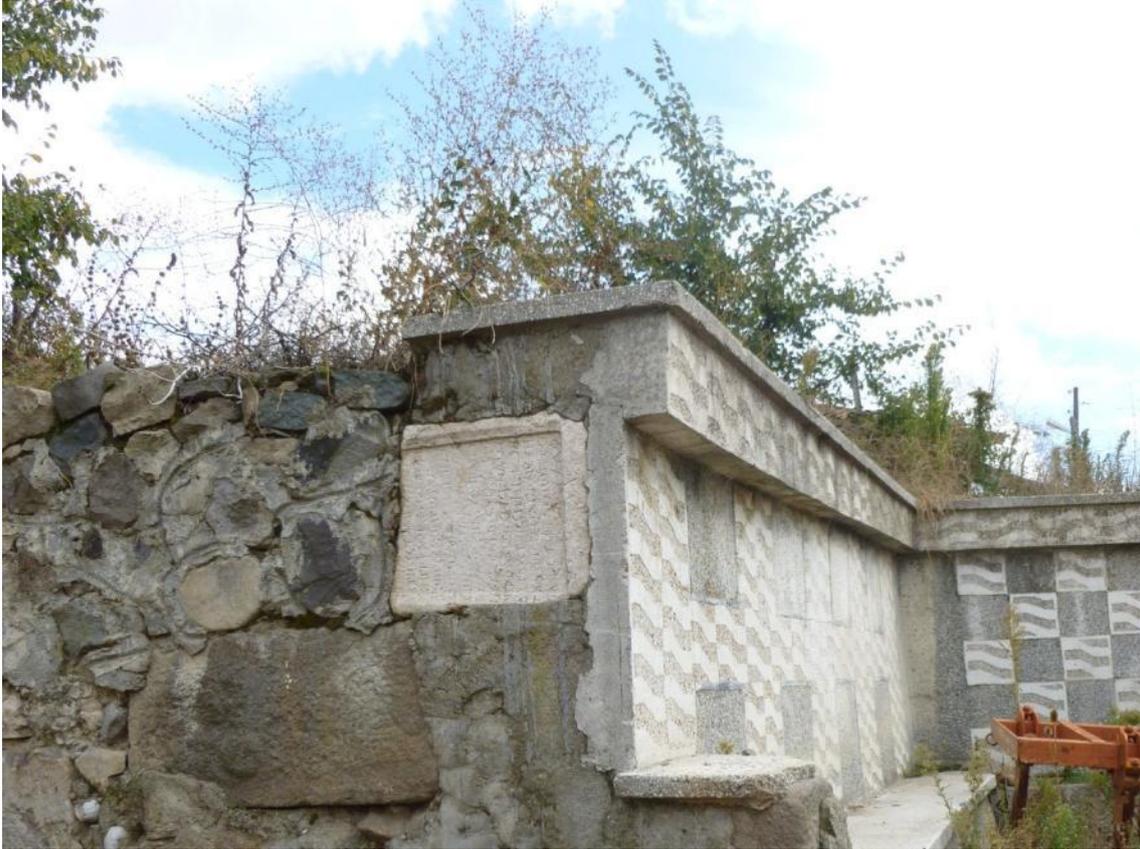
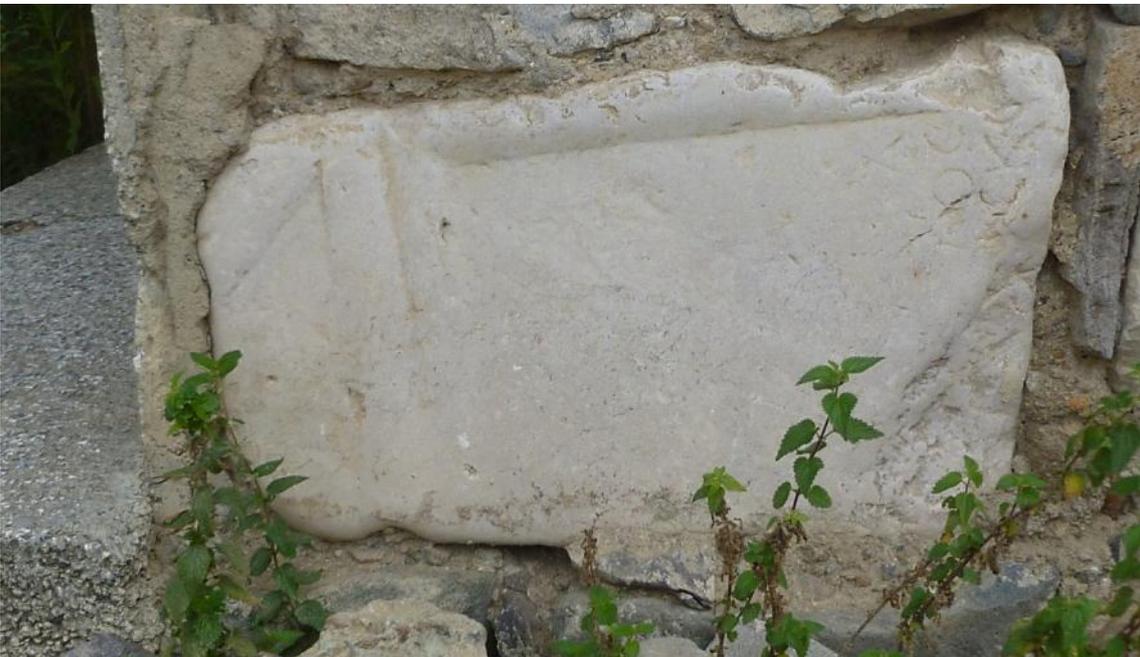
In Ortaklar village, a column fragment c. 0.7m long and with a diameter of 0.33m was observed lying on the ground at UTM715368/4545191. Two inscriptions were also seen in a farmyard at UTM715240/4544800 (figs 12-13). These were observed by Eckart Olshausen when he visited the village in 1988, but have not been published.

12. Inscriptions in Ortaklar village (photographs by Vera Sauer)

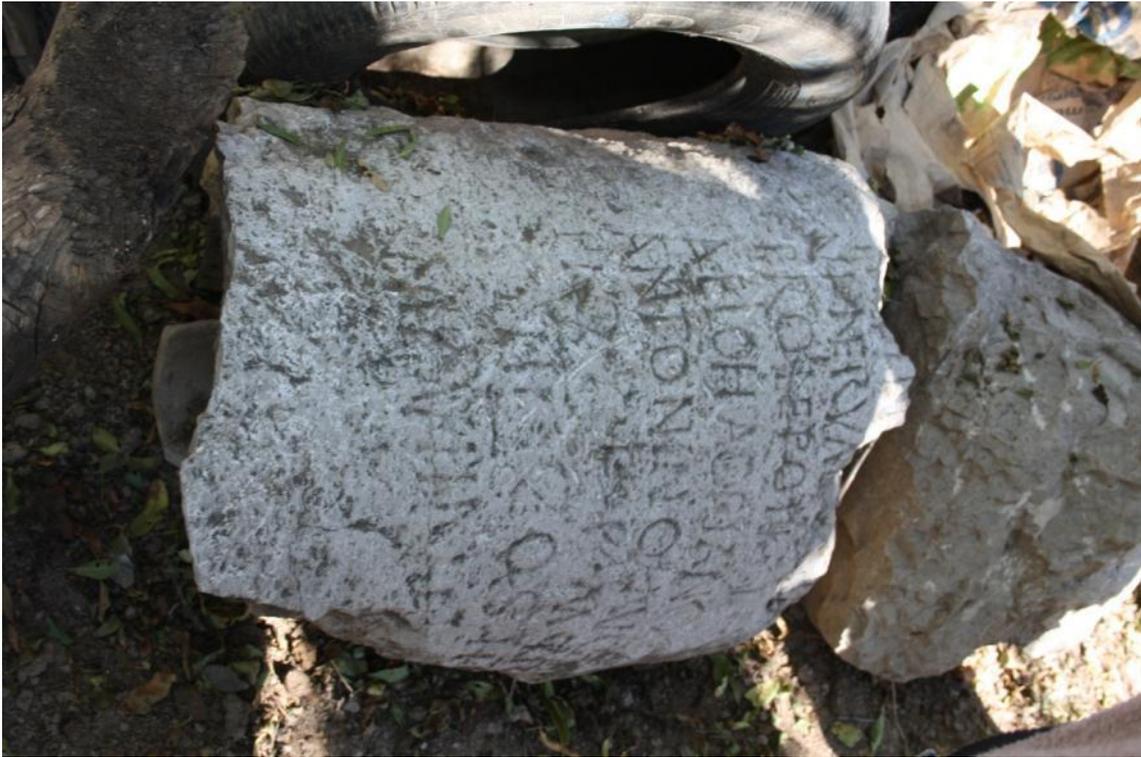
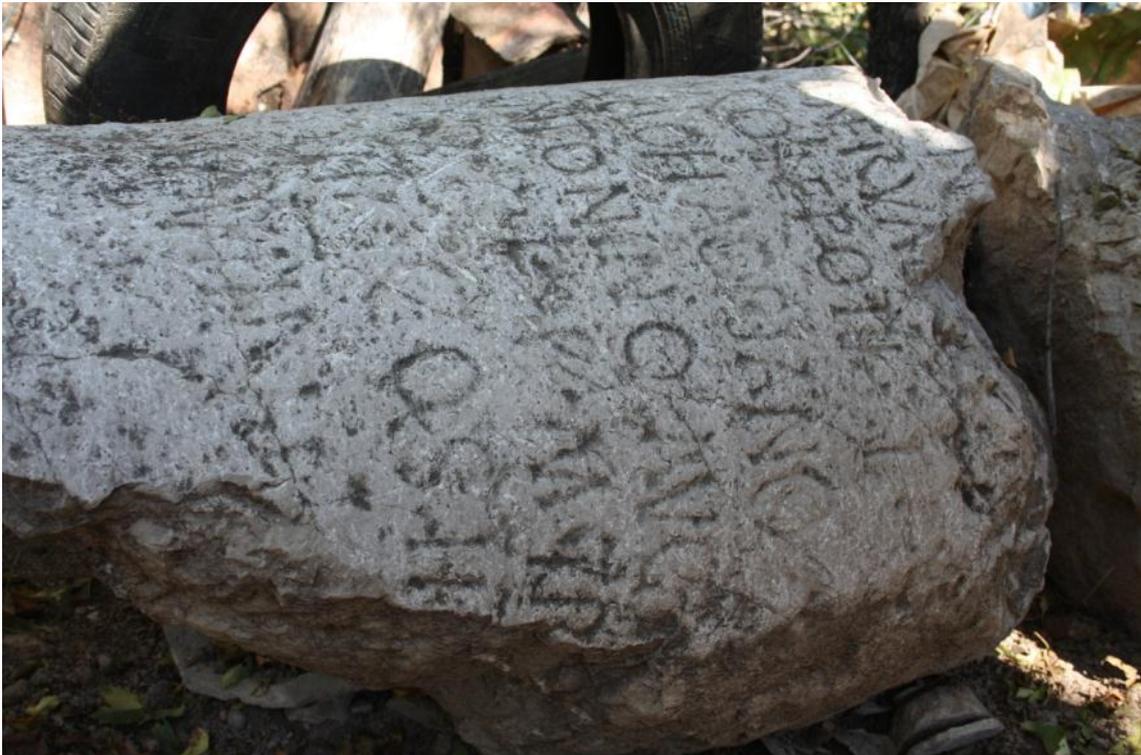
Two milestones were observed in Arica village, one of which had previously been seen by Eckart Olshausen and also, so we were informed, by David French. When Olshausen visited the village in 1988, the stone was standing upright as a pillar under a house in the village. It is now broken in at least three pieces, two large and one or more smaller fragments, and lying in a vegetable garden (figs 22-23).

22. Milestone in Arica village, broken in two.

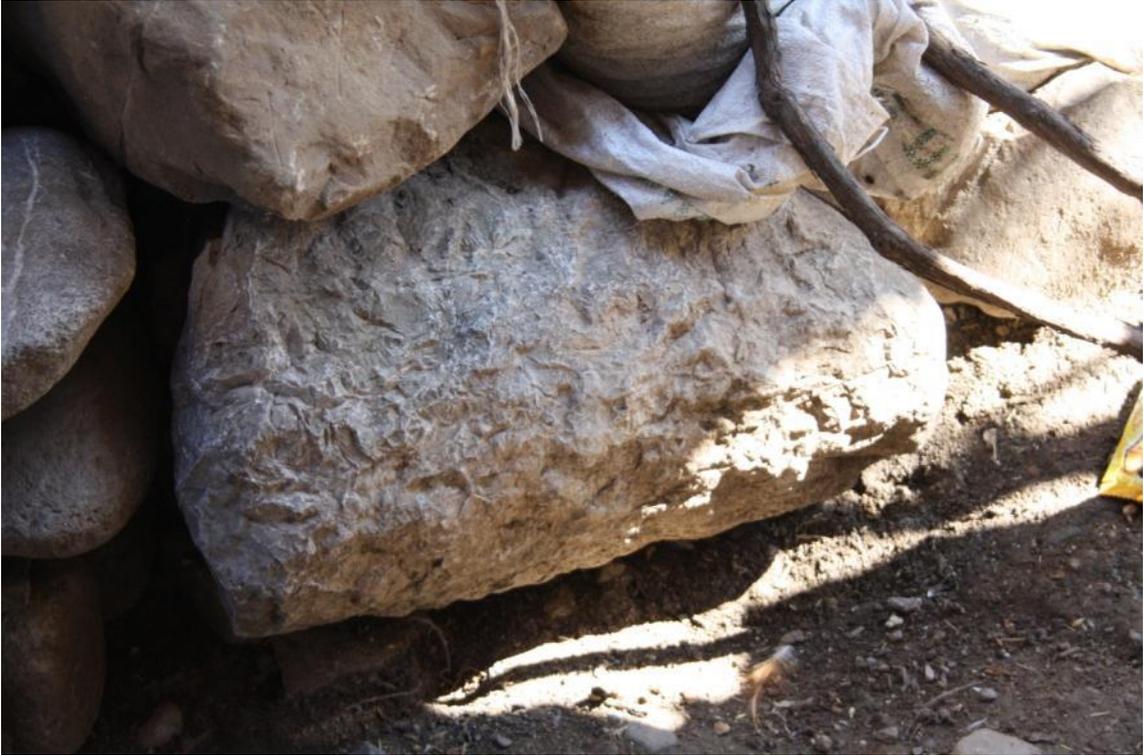
A second milestone has been incorporated into a drystone fence within a garden at UTM699150/4556943 (fig. 24). We are grateful to local informants for drawing our attention to this stone, which is not immediately visible from the road, nor immediately identifiable as a milestone fragment since its inscribed face is turned inwards. Milestones have also been found in Incesu village (Bekker-Nielsen 2010).

24. Fragment of milestone built into drystone wall.

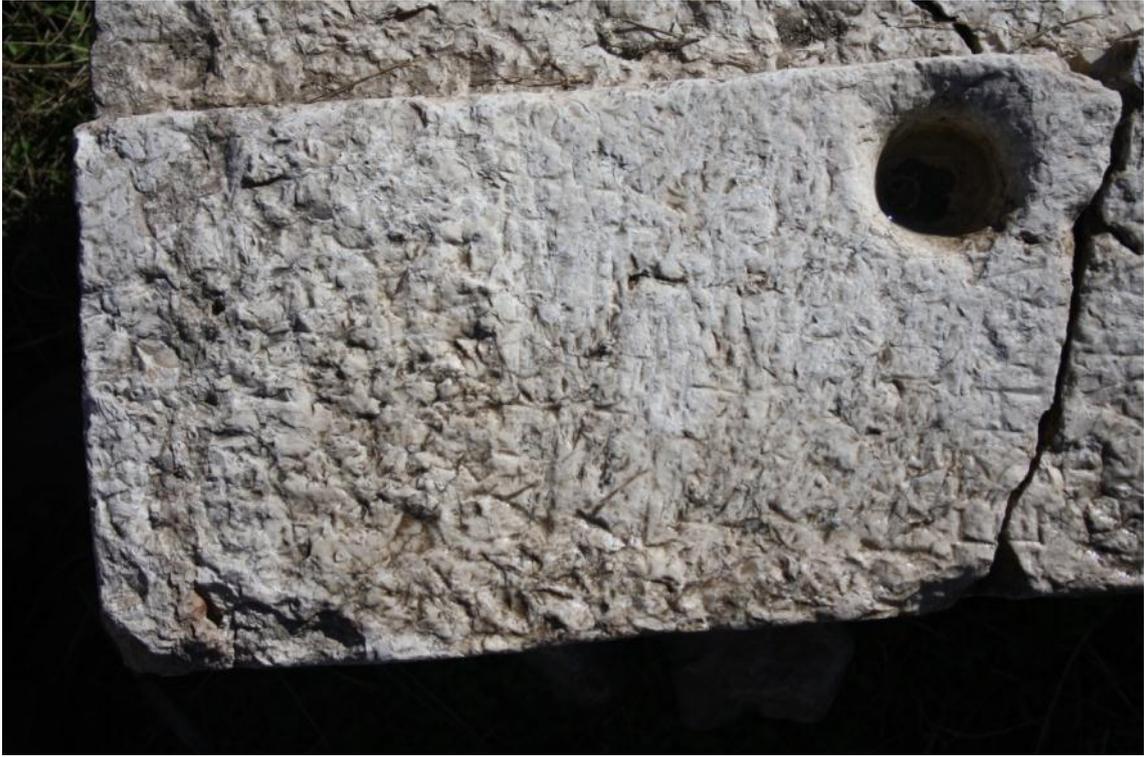
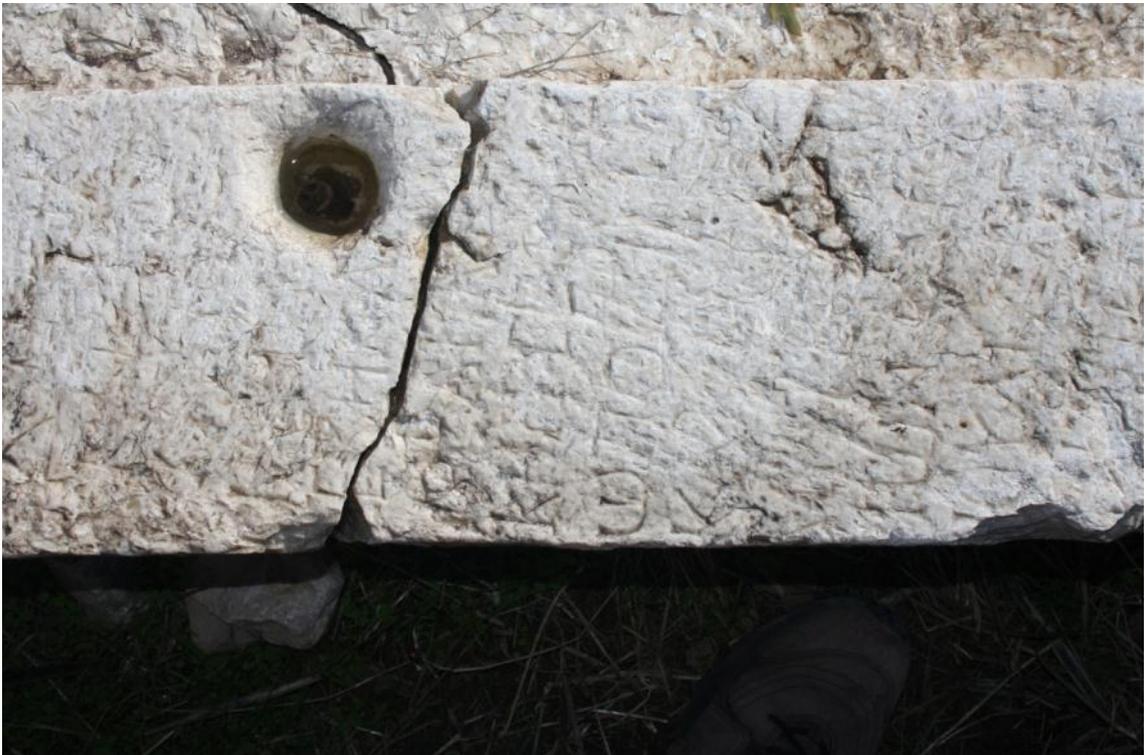
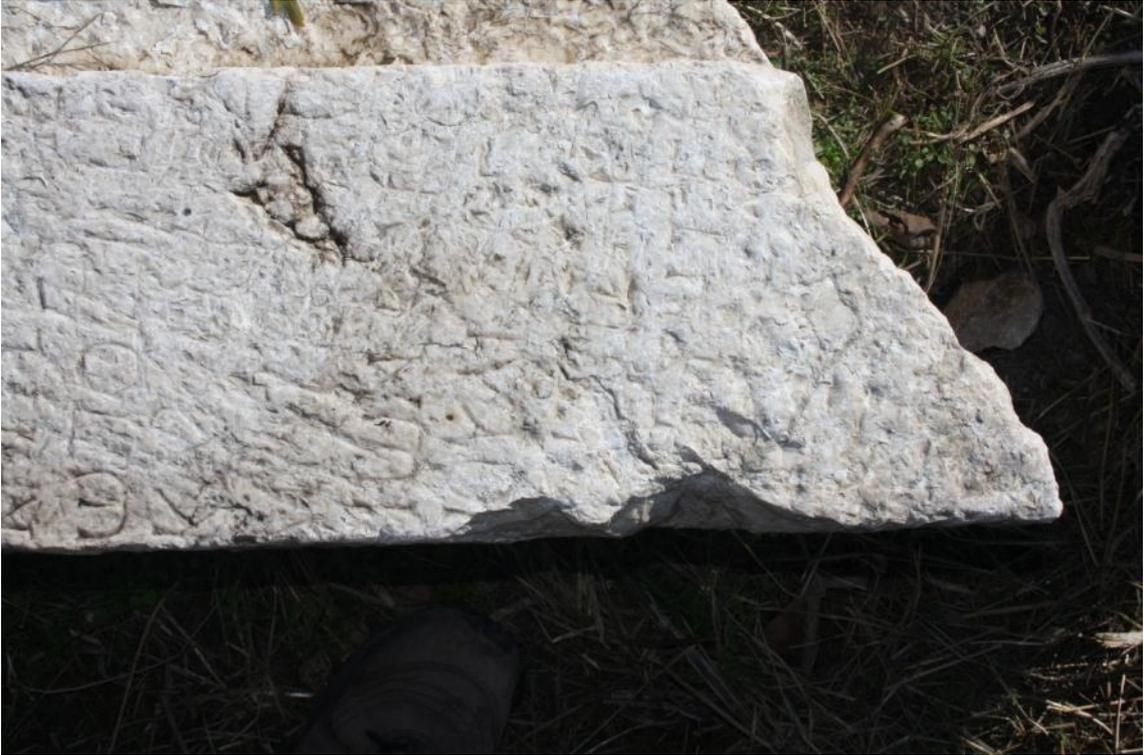
In Tekkekıran village, numerous spoils were observed in the grounds of the school and in a wall at UTM718853/4554946, as well as an unpublished inscription, broken in two, at UTM718646/4555025 (figs 30-32). When this was re-used as a threshold, most of the text was chiseled away, and only a few letters and words can be deciphered. We hope to continue work on this stone in April 2014.

30. Damaged inscription, Tekkekiran.

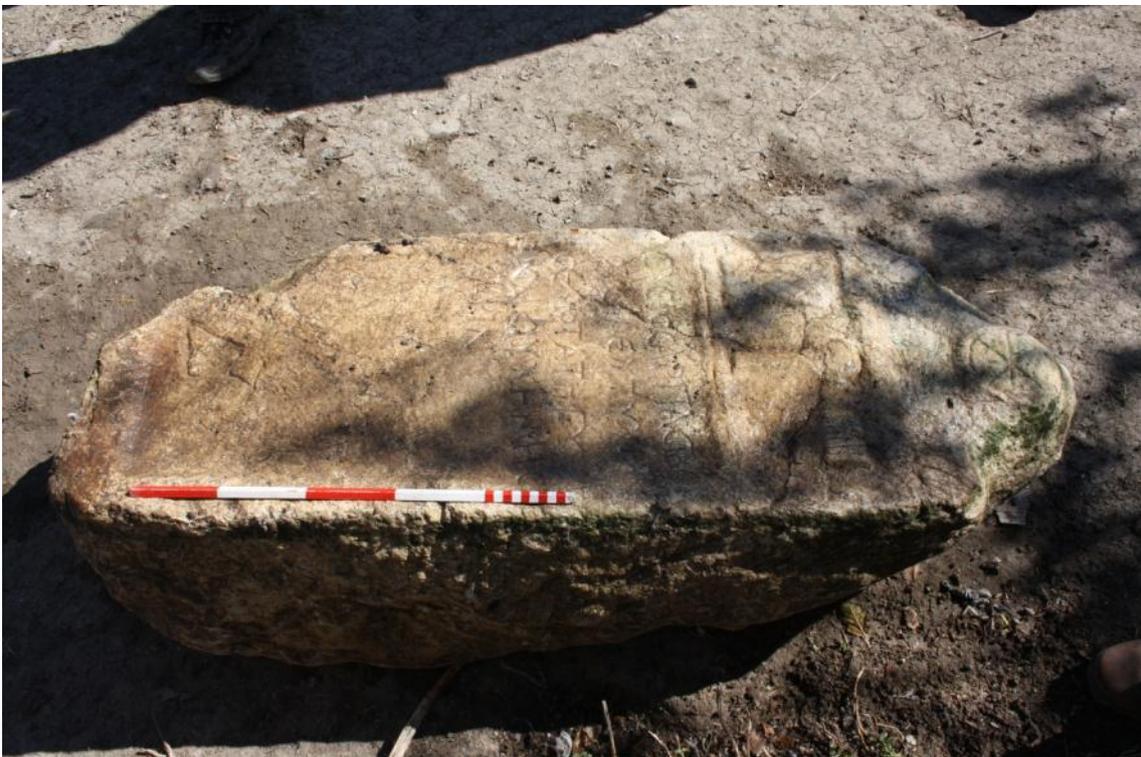
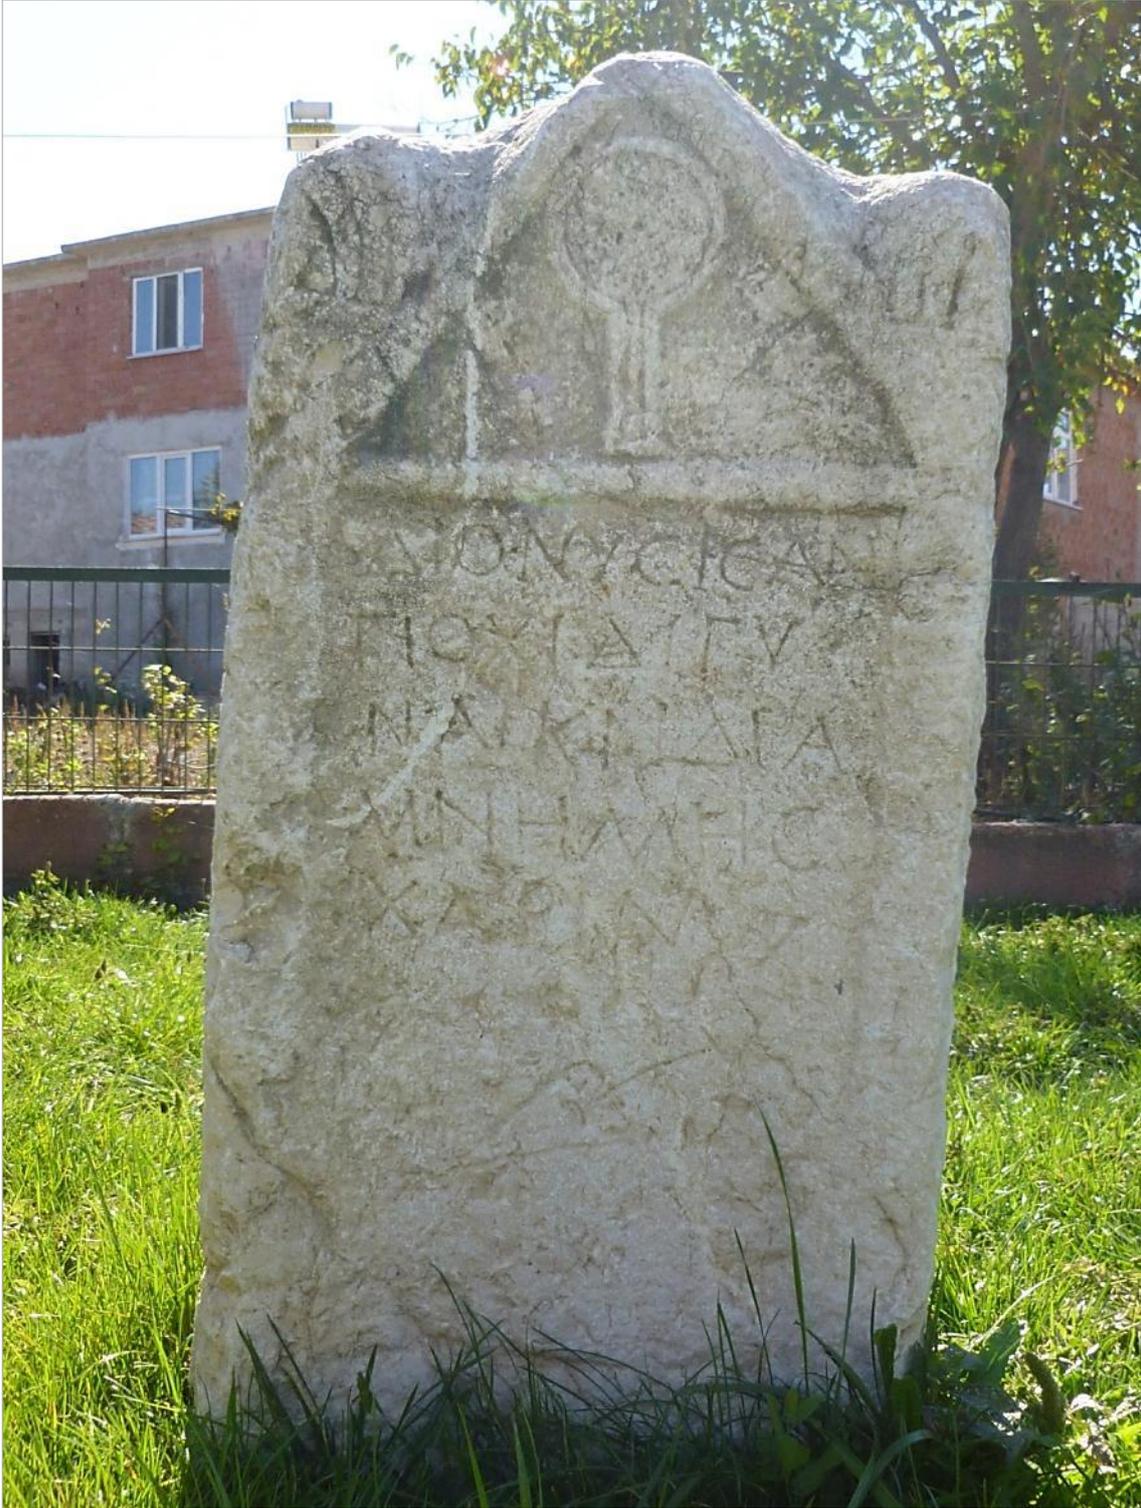
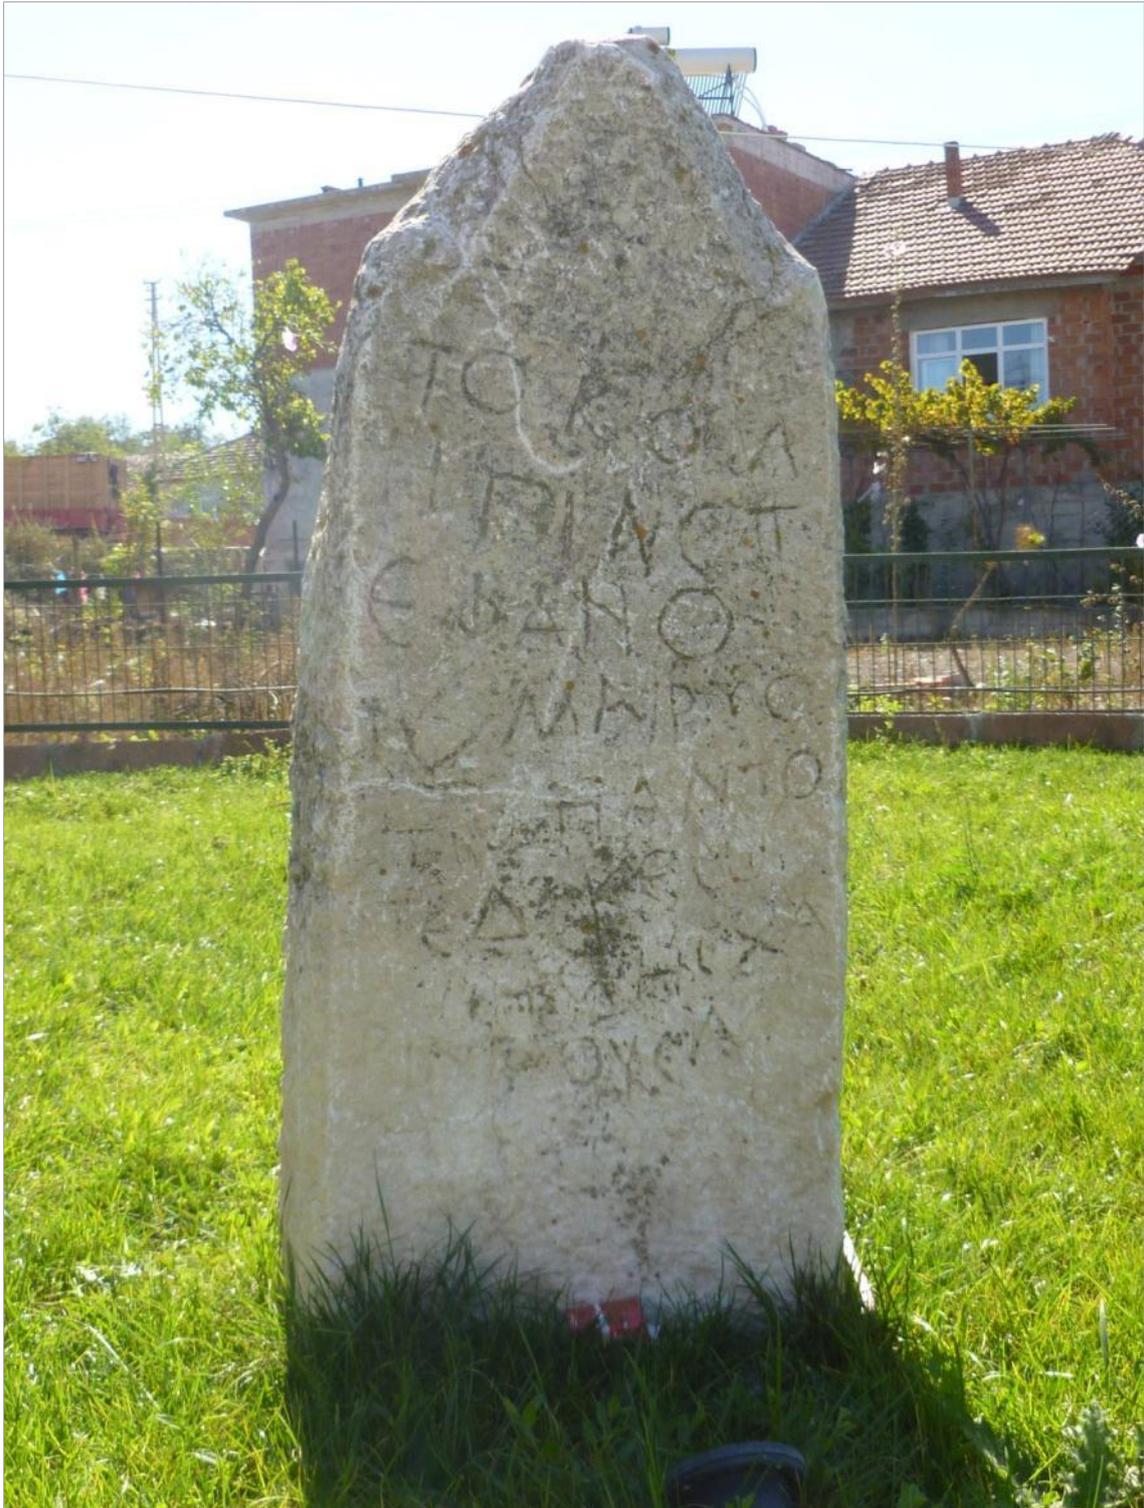
In Ilıca village itself, we saw a series of inscriptions in the village square, three of which have not been published; we were also shown an inscription lying on its face in a farmyard at UTM726420/4548753 (figs. 35-37). Two of the inscriptions in the square as well as the inscription in the farmyard were seen by Eckart Olshausen when he visited the village in 1989. A further inscription was reported to have been found in or near the çeşme behind the mosque, but the present çeşme is an entirely modern construction and there was no sign of any ancient remains.

35. Inscription in farmyard, Ilica 9548

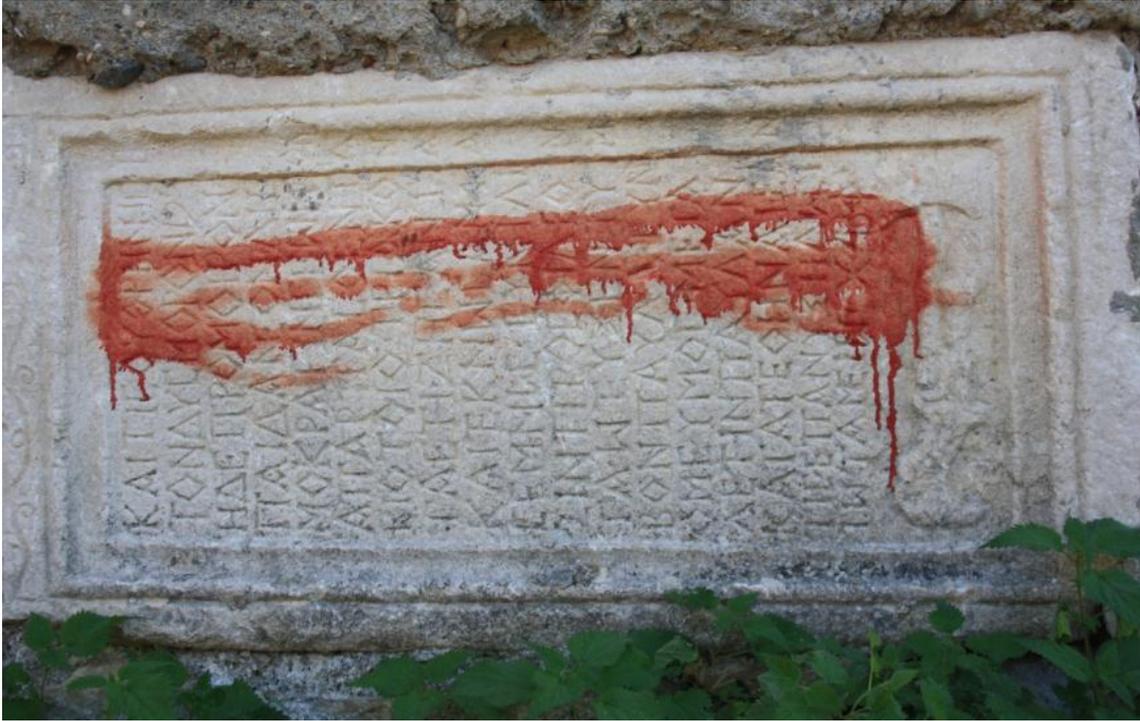
A modern road leaves Vezirköprü on a course ENE aiming for Çalköy village. A stele (fig. 38) is built into the exterior wall of the mosque at Çalköy (UTM710225/4558721). The inscription was photographed by Eckart Olshausen in 1988 and has suffered some damage since then. It has not been published.

38. Inscription in wall of mosque, Çalköy.
