Field Survey in Vezirköprü and Havza Districts, October 2013

Ass.Prof. Dr. Tønnes Bekker-Nielsen, director

REPORT

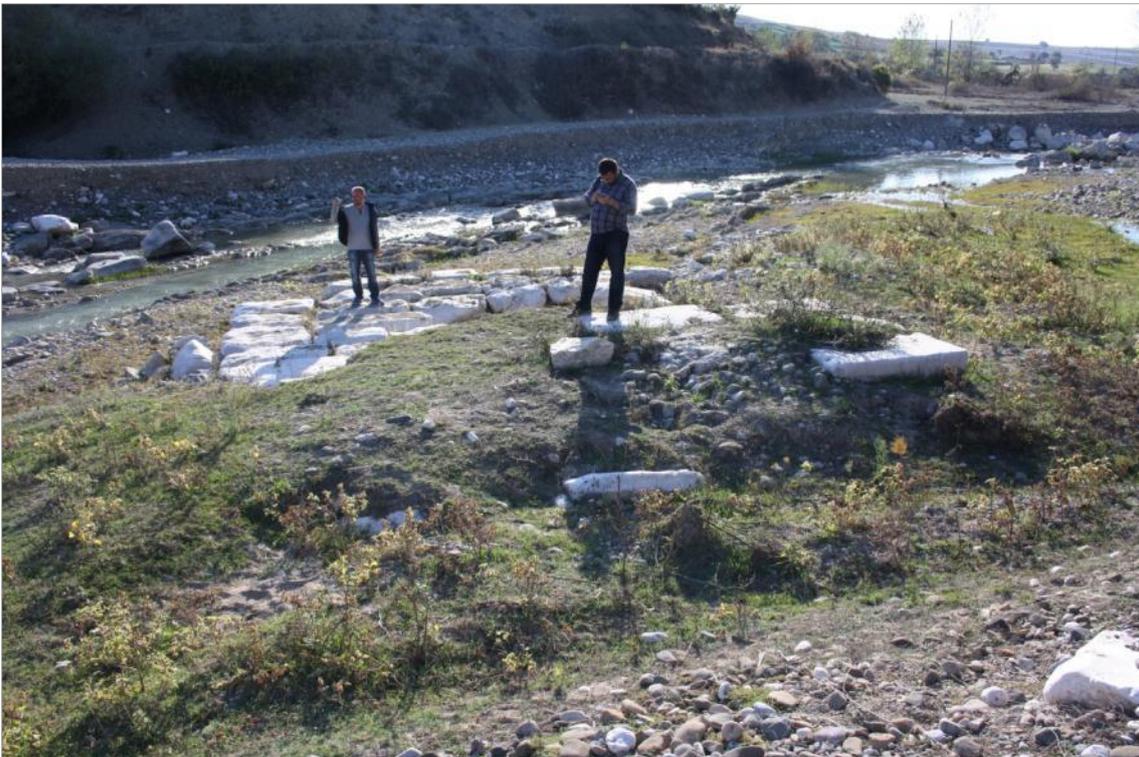
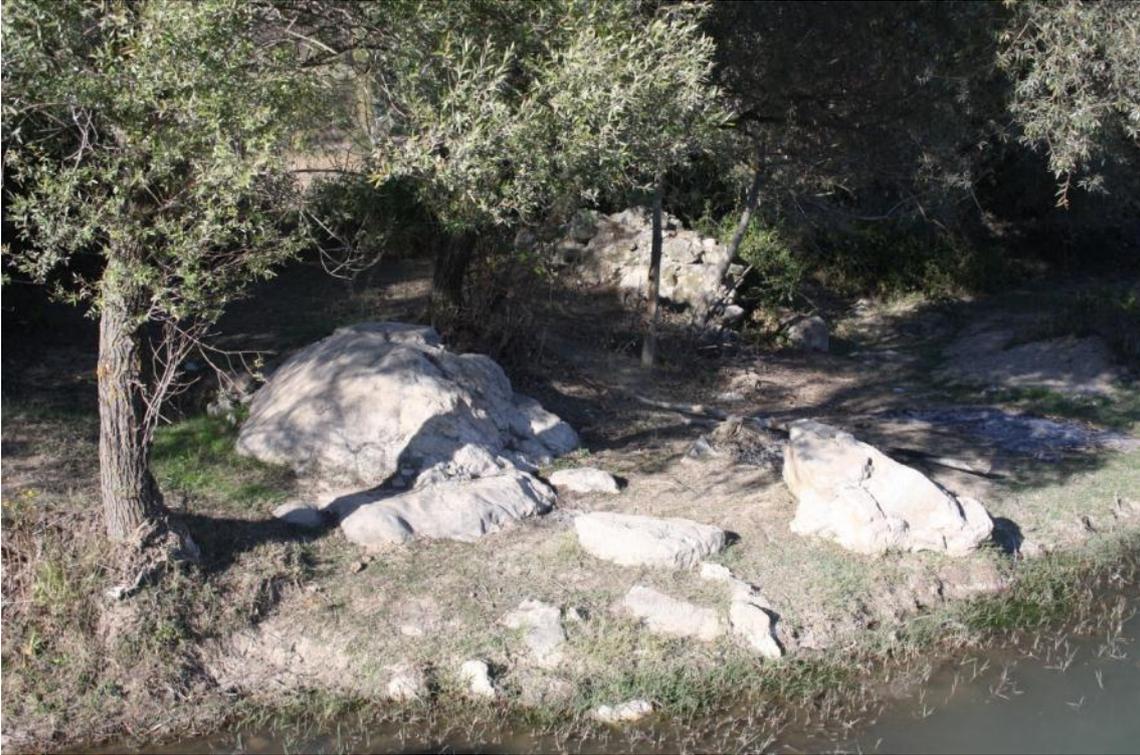
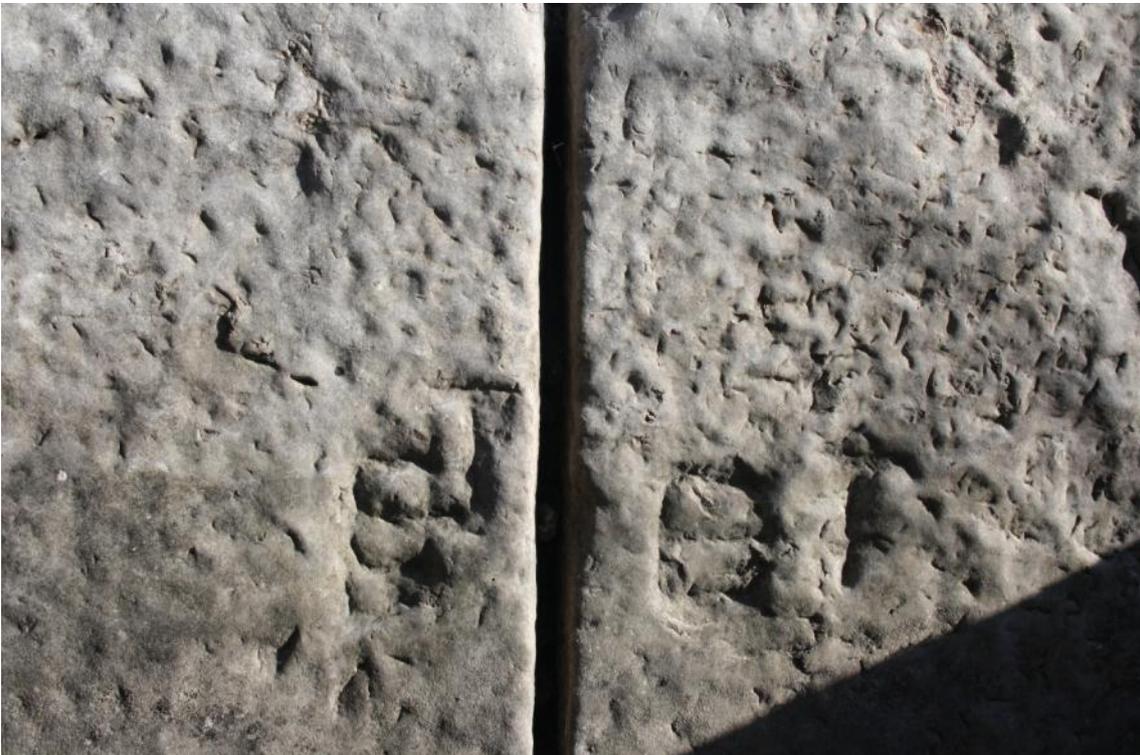
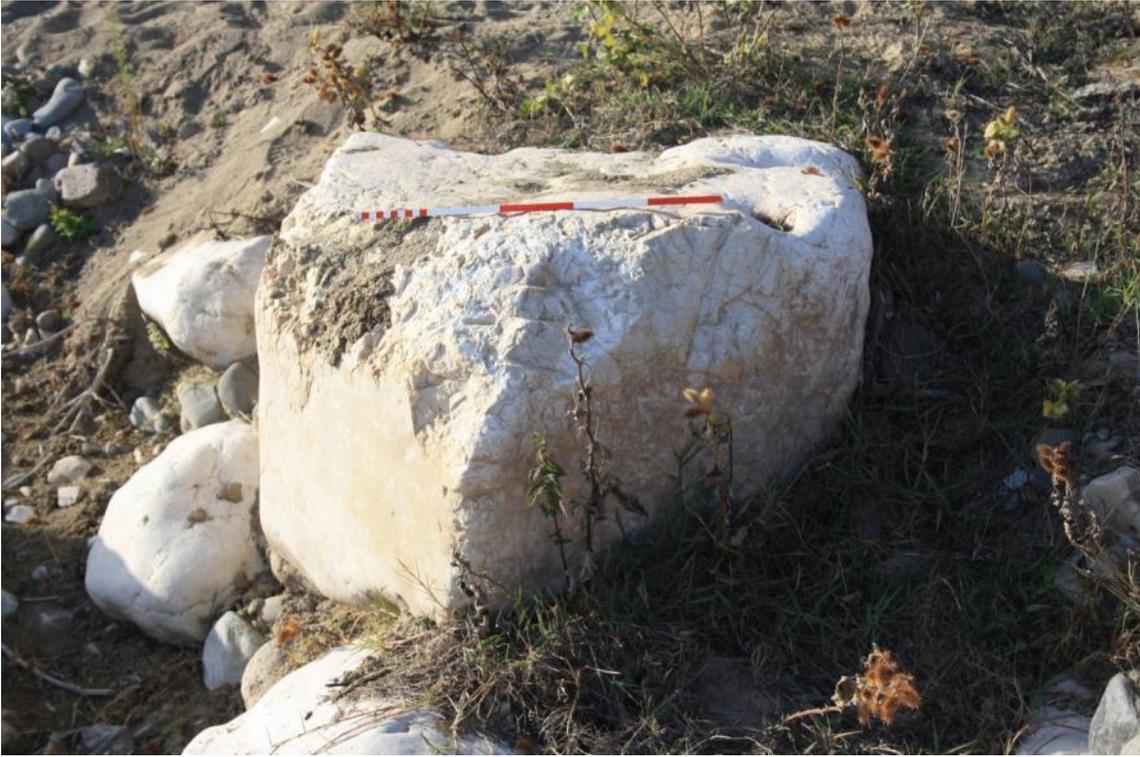
Below the village, large blocks, obviously from a concrete structure, can be observed in the stream. A short distance upstream, the remains of a multi-pier bridge over the Kuz Çay (figs. 39-42) are visible. The layout resembles that of the bridge at Köprübaşı with a series of large stone-built piers that probably supported a wooden superstructure. Counting from the north bank, pier no. 1 is now on dry land and has lost its outer facing of dressed stone, save for one stone that formed the tip of the cutwater. In the location where pier no. 2 would be expected, one finds a massive rock cropping out of the earth, presumably a natural feature that was utilised as a pier. Pier no. 3 is well preserved with much of its outer stone facing intact, whereas pier no. 4 is preserved to foundation level. None of the piers have cutwaters on the downstream side. No remains of further piers are visible, nor of a bridgehead or an ascent on the south bank. We are grateful to Bünyamin Kıvrak for drawing our attention to this monument.

39. Remains of bridge at Yürükçal. The government representative (furthest from the camera) is standing on the paved bed of the stream.

40. Natural rock formation used as pier no. 2. In the background, the concrete core of pier no. 1.

41. Mason's marks on outer facing of pier no. 3.

42. Tip of cutwater from pier no. 4.

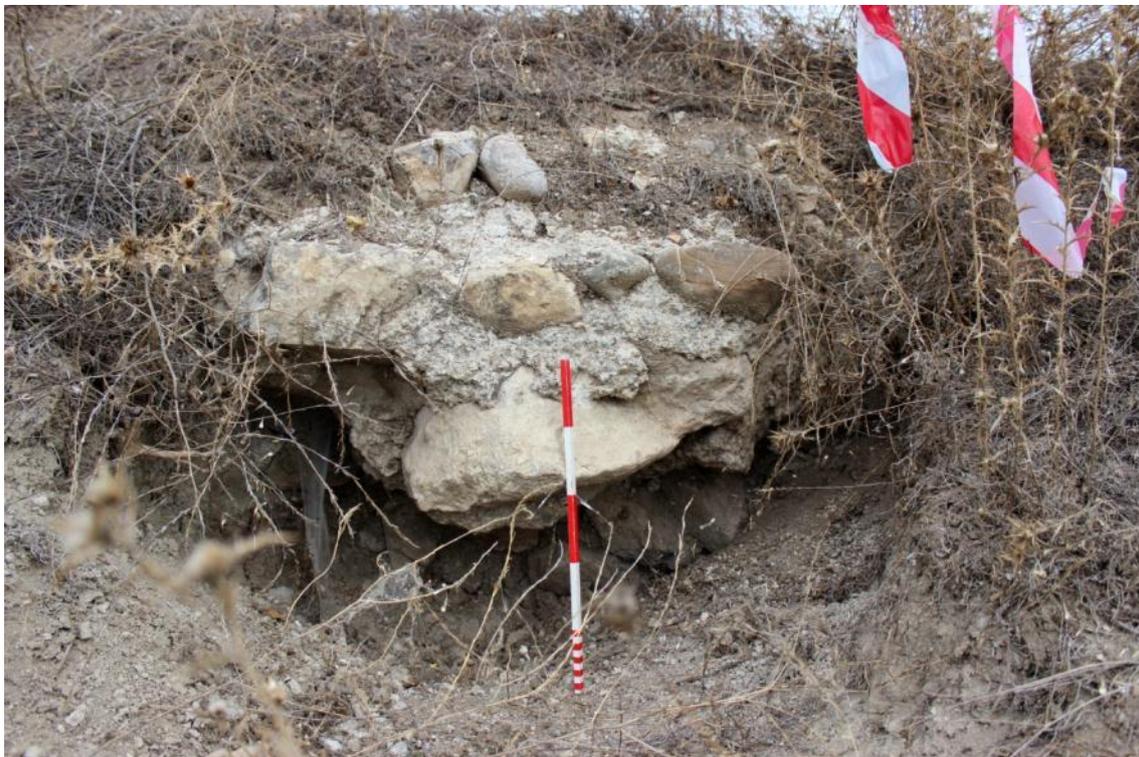
48. Finds: exposed foundation of the southeast corner of the square building

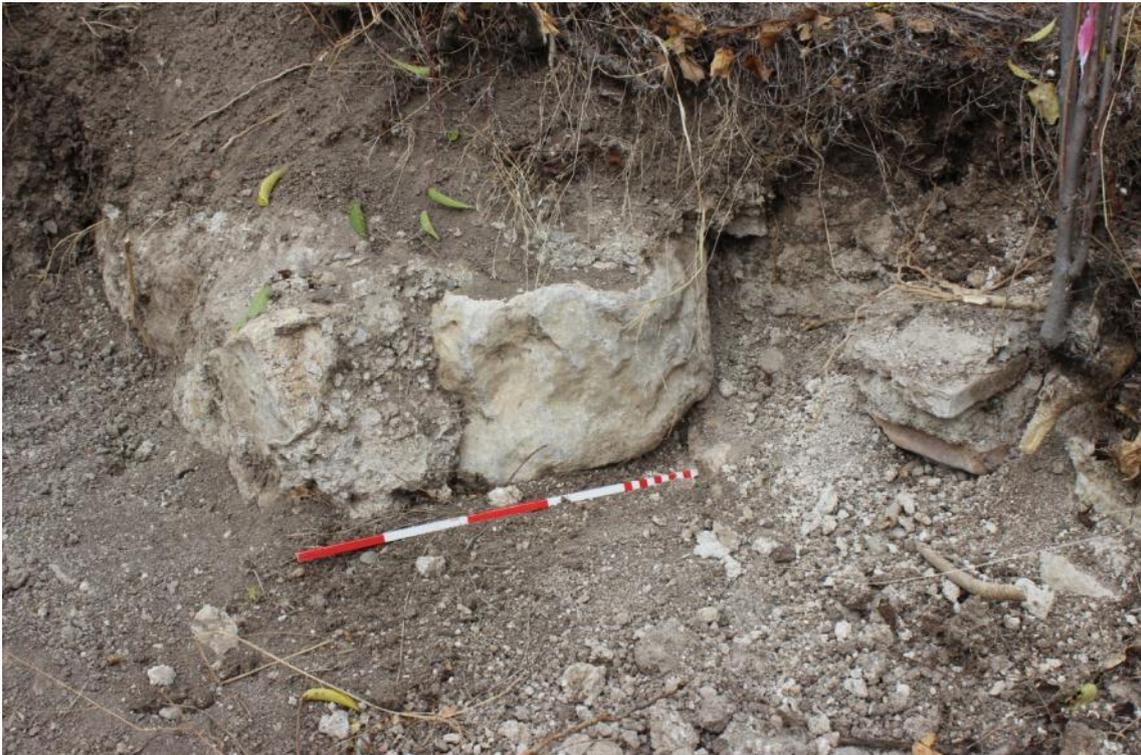
57. Finds: exposed foundation in the slope south of the square structure

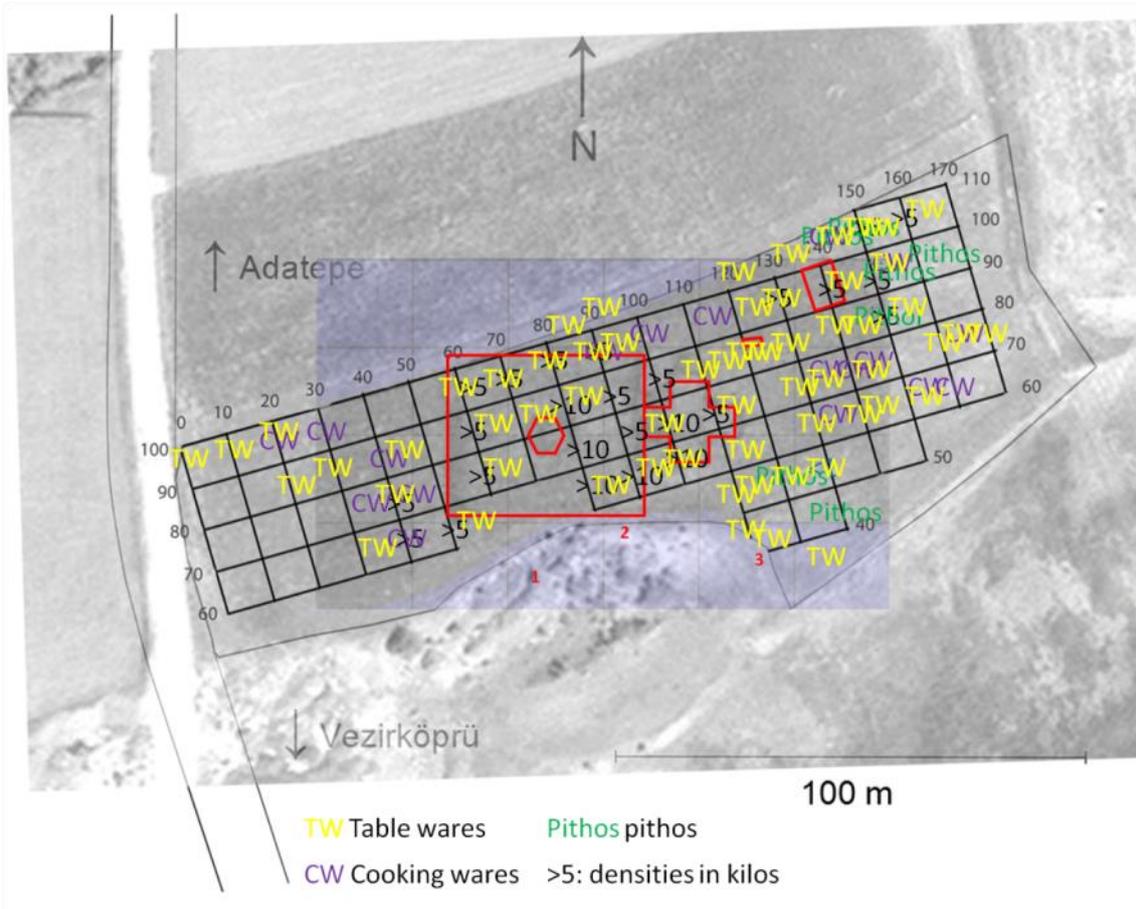
Several observations can be made based on the overall distribution of the different use-categories (Fig. 69). Tiles are not included as they are found all over the field, although clearly concentrated over the structures (see above). Fig 47 can be viewed as a tile distribution map due to the size and therefore predominance of this type ceramics when weighed. As mentioned before, the distribution of pithoi appears to be highly significant. The majority of fragments came from the north-eastern part of the field where the combination of tile, pithoi, kitchen, cooking, table wares and iron slag suggests a combination of domestic and productive activities. Some functional differentiation may be hinted at in the distribution of pithoi which seem to concentrate in the northeast and cooking wares which seem to concentrate to the south, but the collection in the squares was not systematic and consequently this patterns should not be over emphasised. The pithos fragments found in the central south corner of the field are explained by the topography. These large fragments have probably rolled to the bottom of the hill. In the area of the complex with the cruciform structure only kitchen ware and table wares were found, which may be another indication of functional differentiation suggesting that cooking and storing took place in the north-eastern complex. However, there seems to be a concentration of cooking and table wares west of the large square structure either originating in the structure or indicating the existence of unknown structures in this area. As deeper foundations have been identified in the slope (fig. 68.3), this is not impossible.

69: Distribution map of cooking wares, pithoi and table wares shown against densities.
