Another ECDIS induced accident: After all these years, why can't we get it right?

T. Porathe, E. S. Petersen, M. Lützhöft

The ErgoShip conference, Esbjerg, Denmark, 2-3 November 2023

Report on the investigation of
the grounding of the general cargo vessel
Kaami
on Sgeir Graidach, the Little Minch, on
23 March 2020

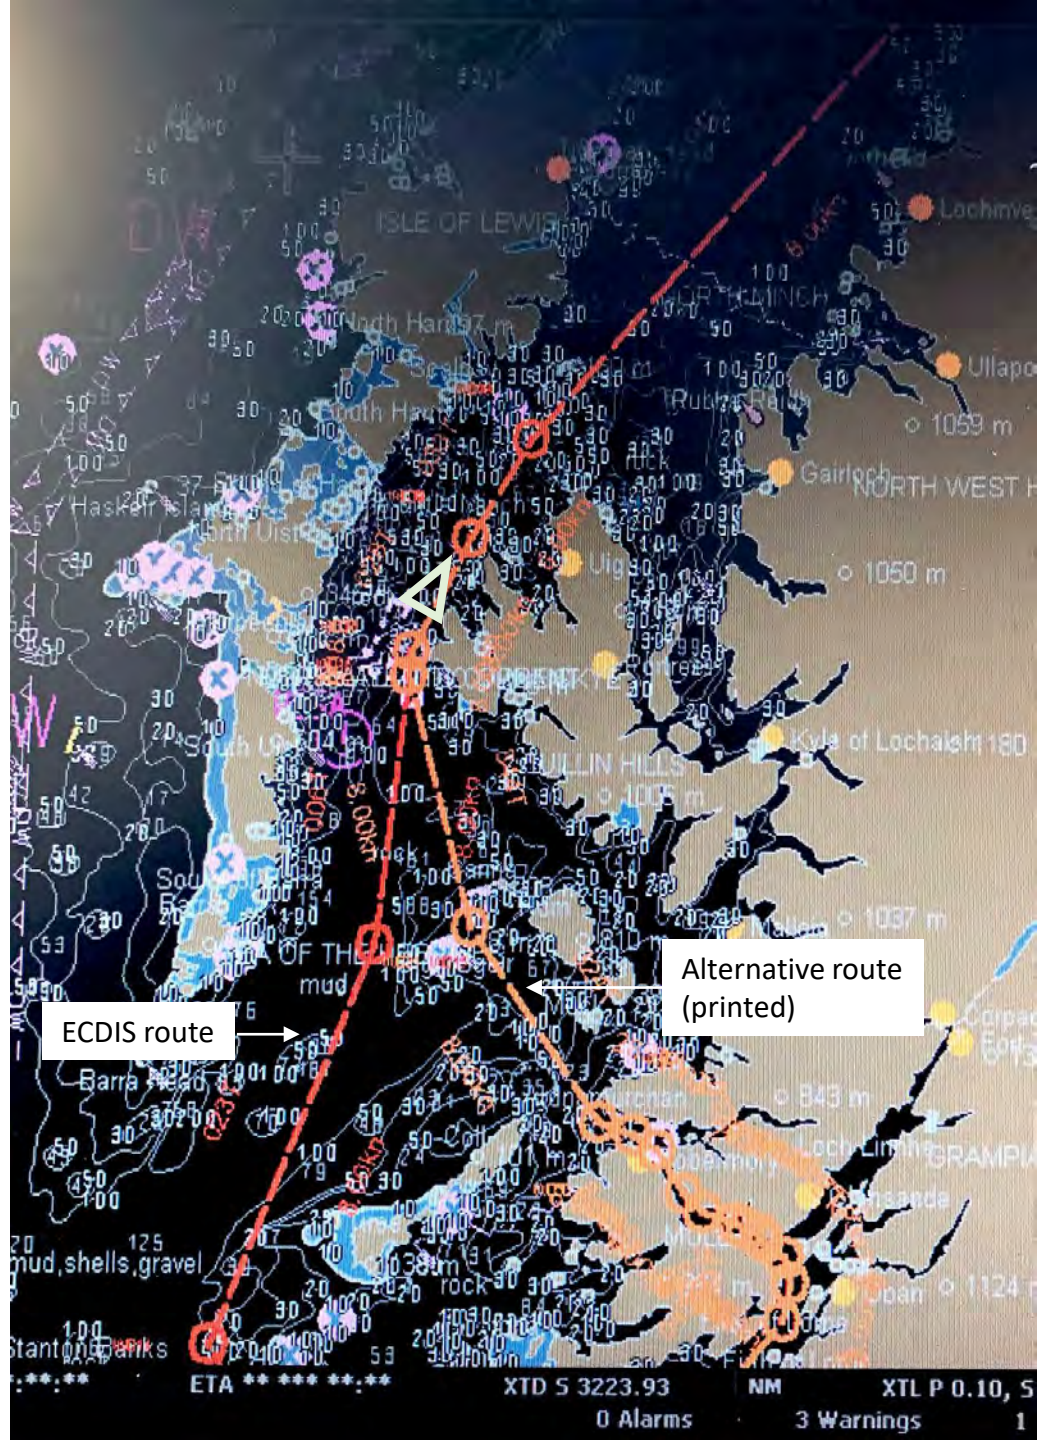
Figure 15: Different routes due to weather routing. Photo of onboard ECDIS. Courtesy of MAIB

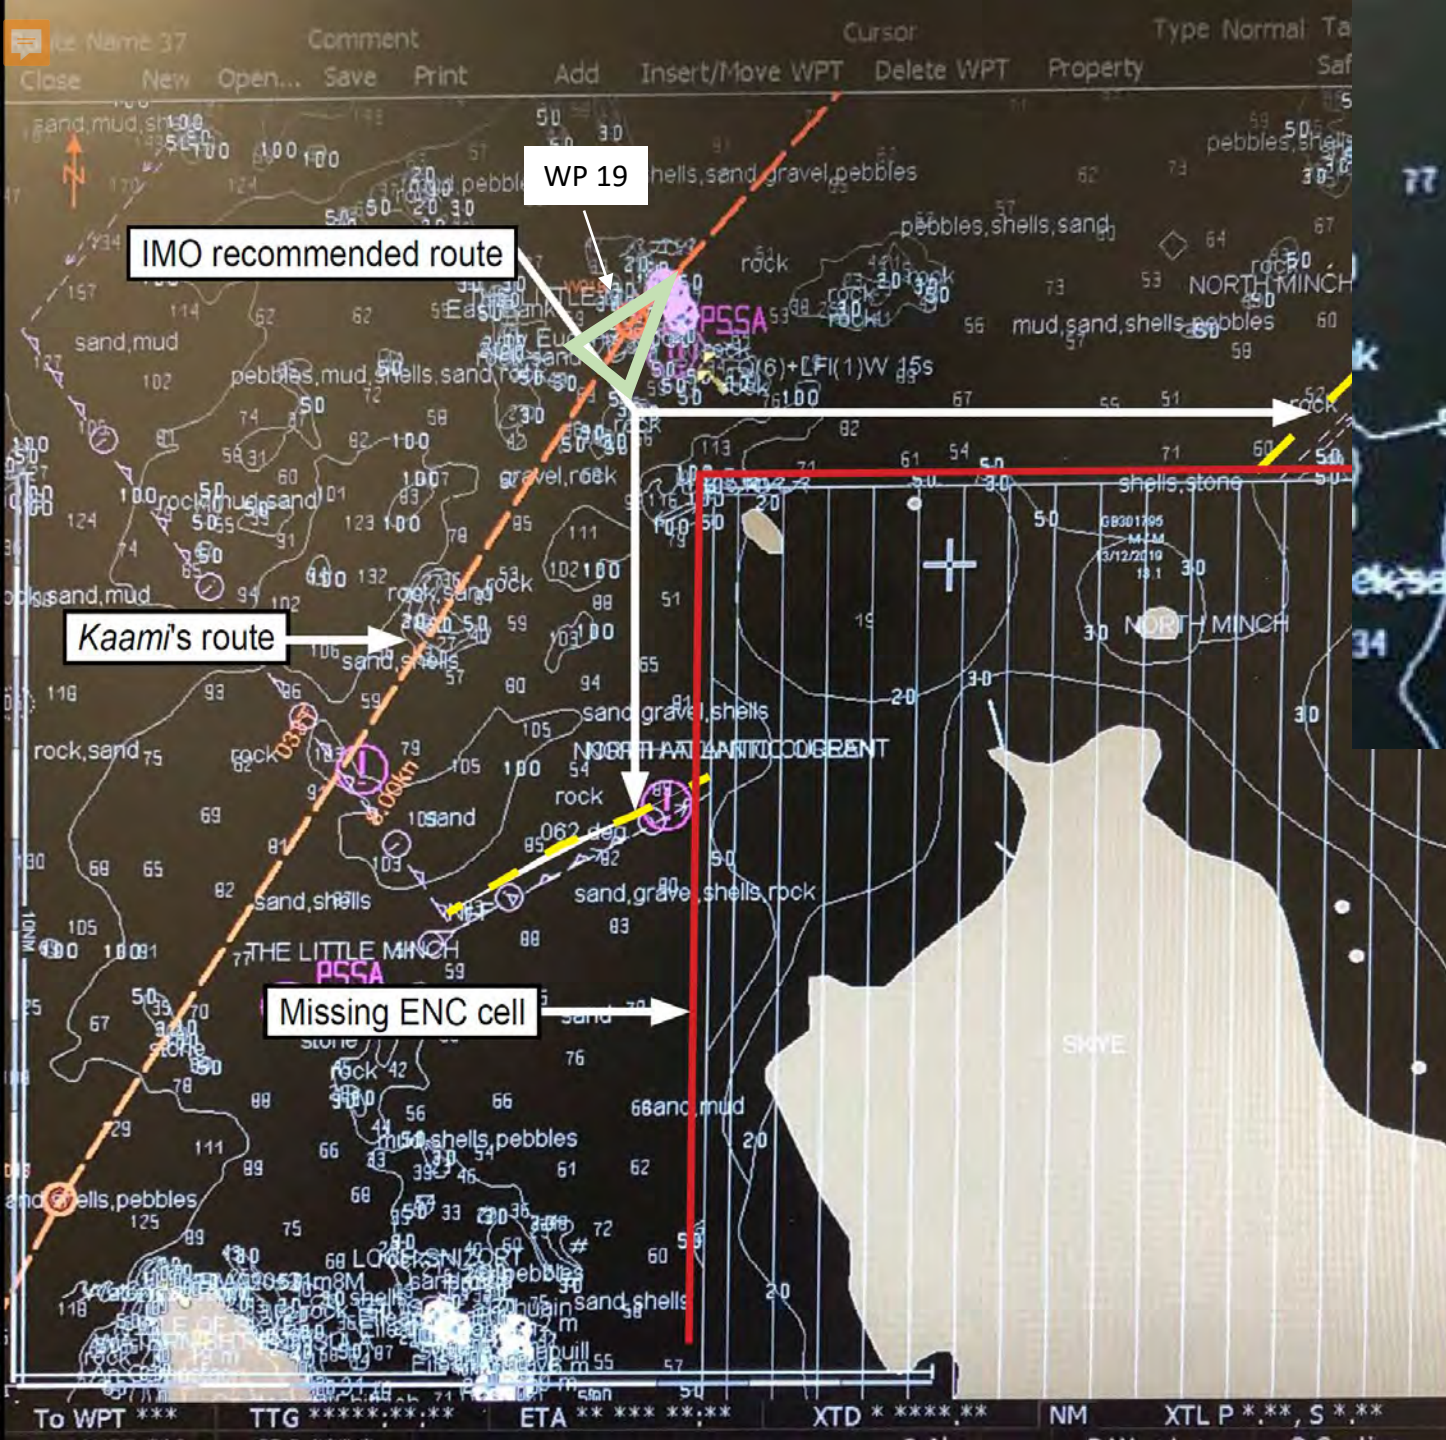
Figure 12: Photo of Kaami's ECDIS display showing route in comparison to the missing cell (indicated by vertical bars) which covered the IMO recommended route to the north of the Isle of Skye. Courtesy of MAIB.

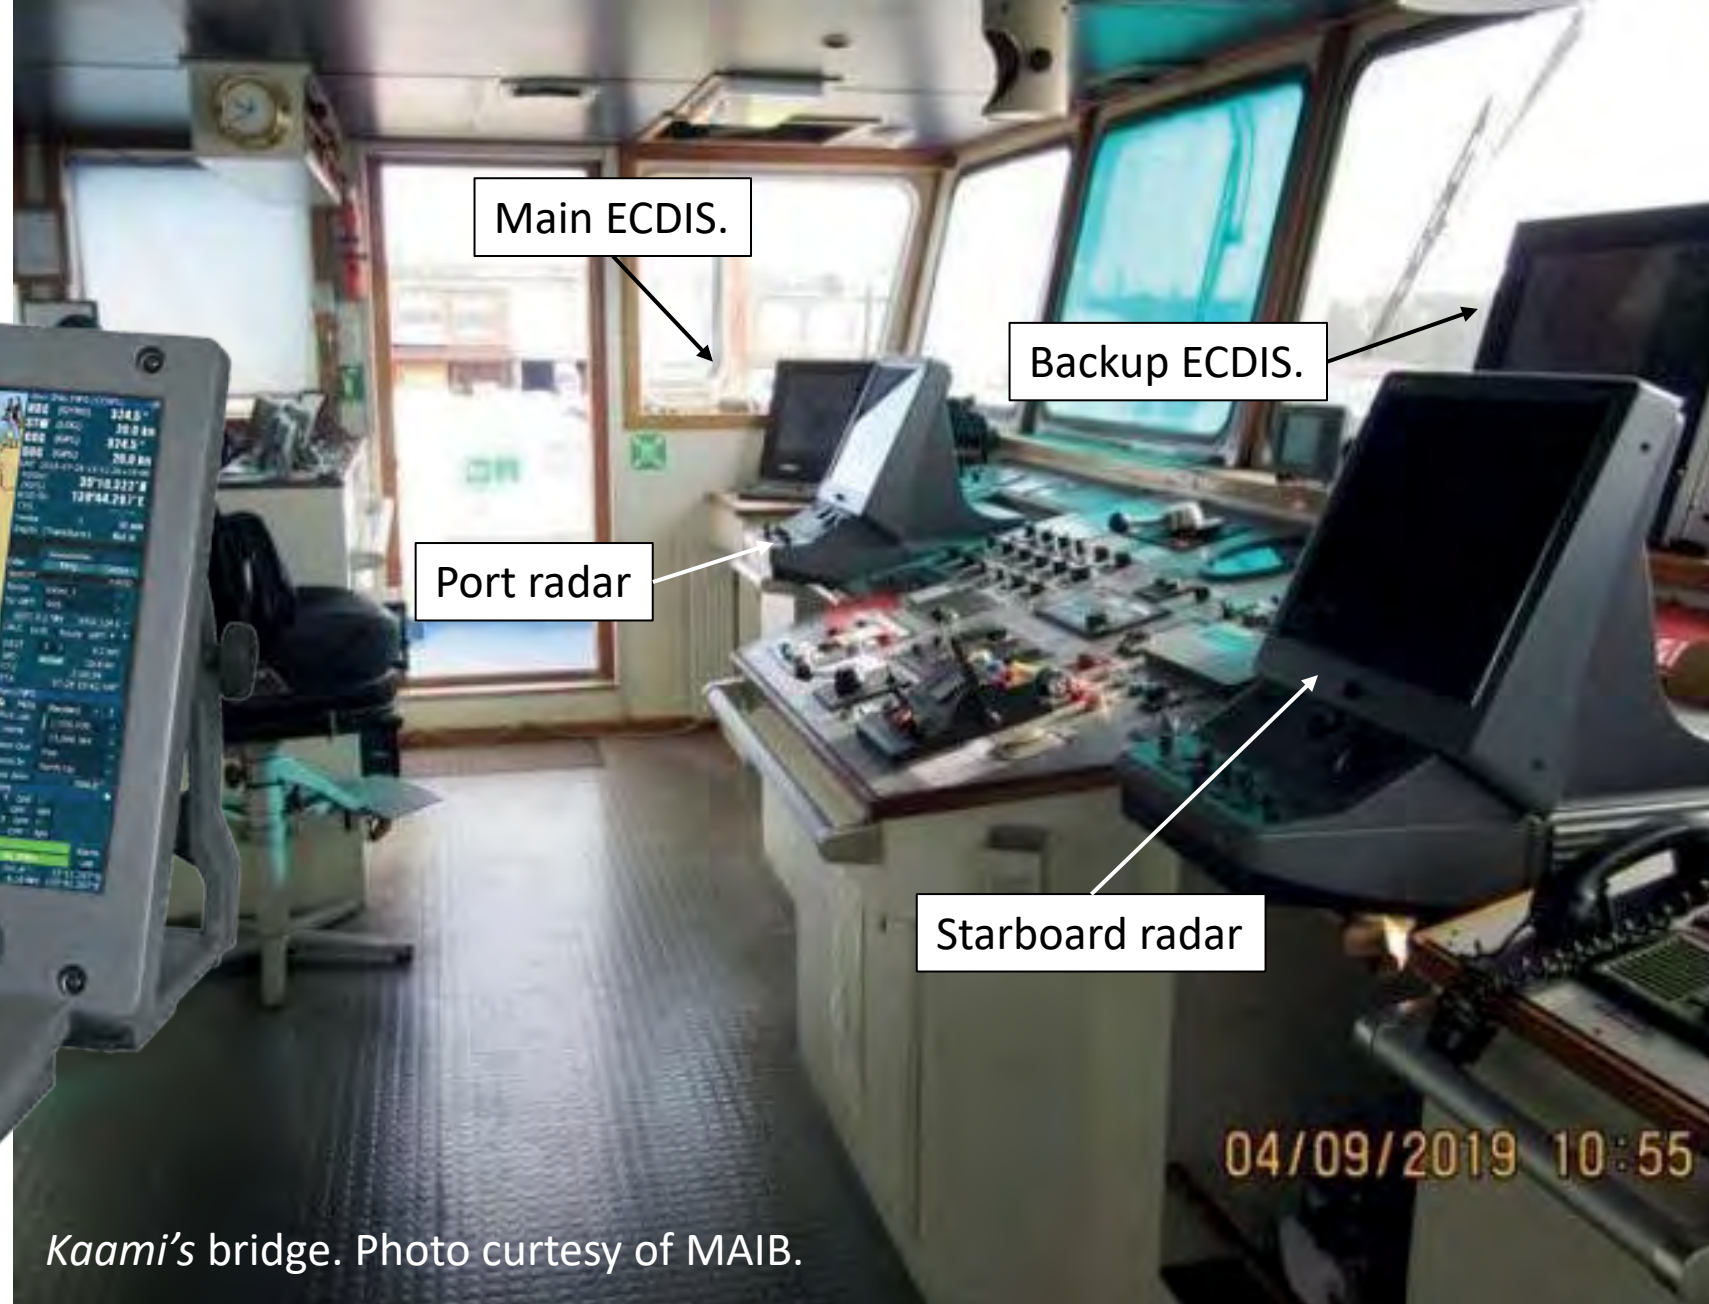
Kaami's bridge. Photo courtesy of MAIB.

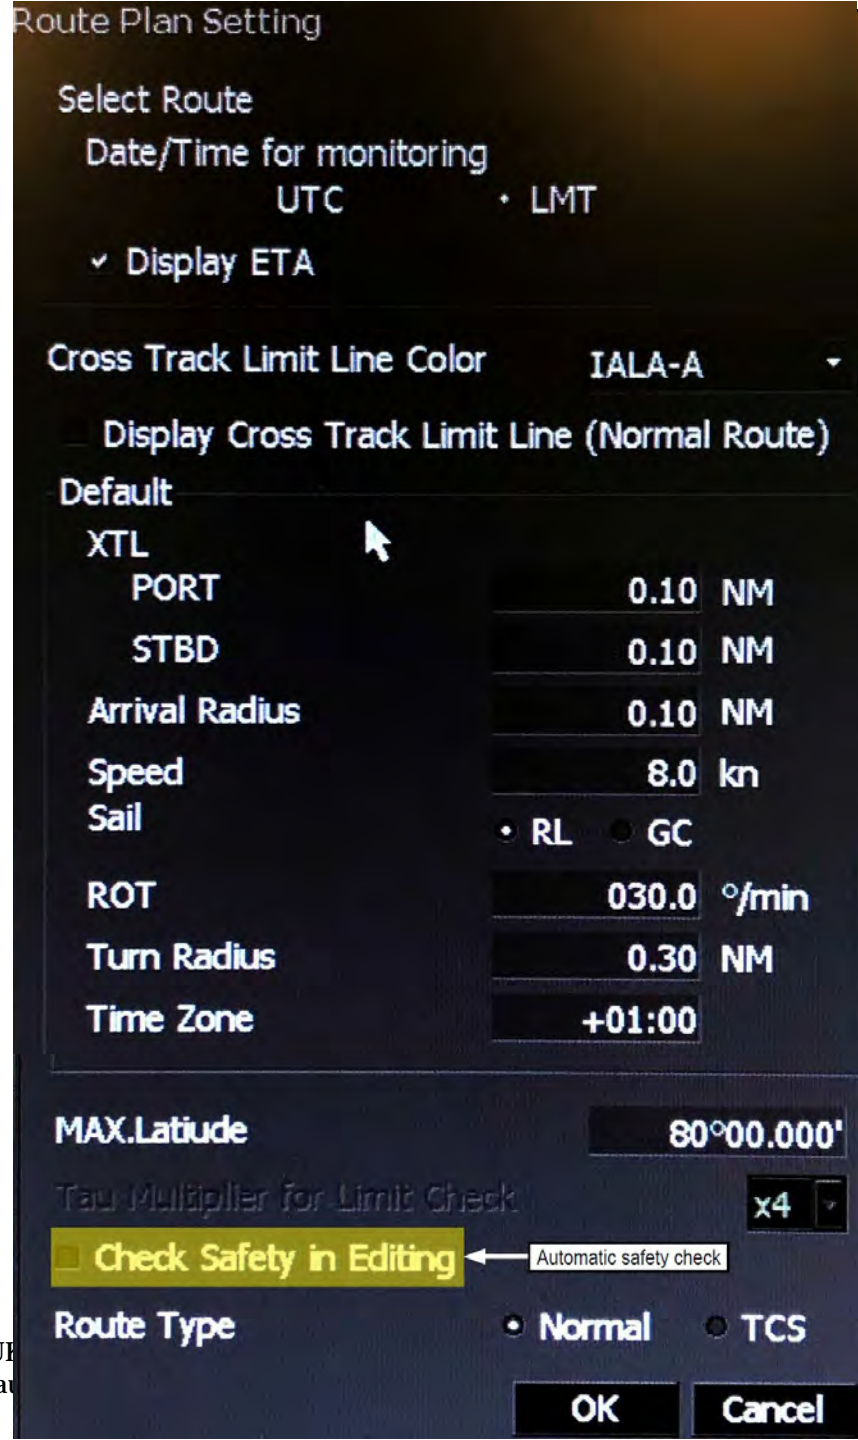
Figure 8: Voyage planning screen showing XTD and safety check. Voyage planning display screen with cross track limit and automatic safety check data highlighted. Courtesy of MAIB
